RESEARCH COUNCIL OF ALBERTA

REPORT 72-5

TRAIL CONDITIONS ALONG A PORTION OF
THE GREAT DIVIDE TRAIL ROUTE,
ALBERTA AND BRITISH COLUMBIA ROCKY MOUNTAINS

J.D. Root and L.J. Knapik

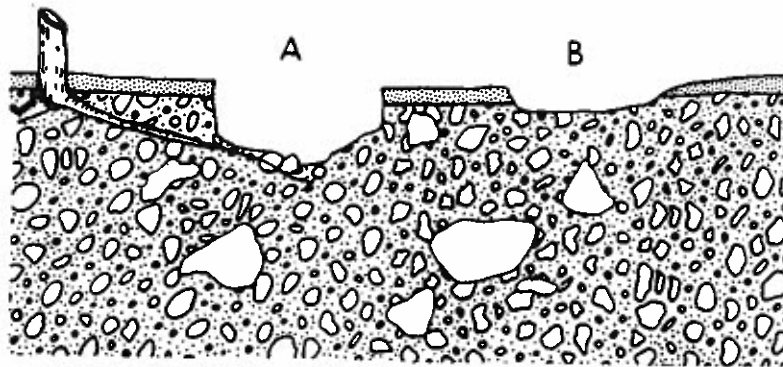
Figure 4. Trail slightly eroded by running water partly exposing pebbles and small boulders. Trail becomes difficult to walk or ride on and is partly abandoned. New trail (B) worn parallel to old.

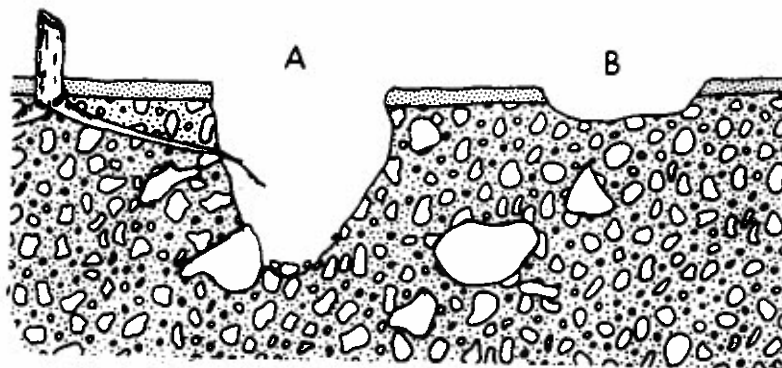
Figure 5. Trail deeply eroded by running water exposing large tree roots and boulders. Loose rocks in trail making walking and riding difficult or impossible. Trail is abandoned for new trail where undercutting of turf begins.

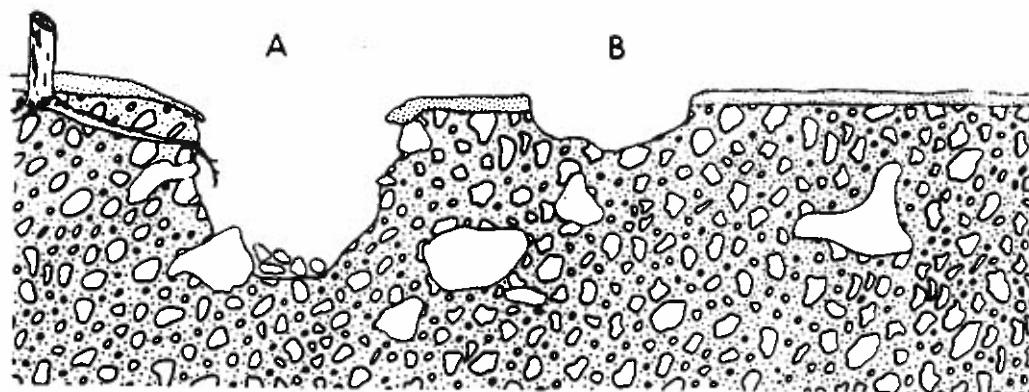
Figure 6. Trail further eroded. Vegetation and root mat is undercut, collapses, and is washed away. More boulders washed into rut, and additional roots exposed. Second trail begins to erode.

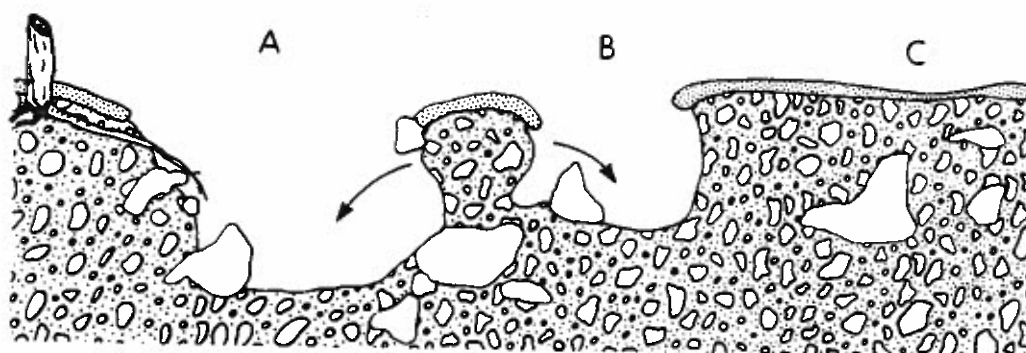
Figure 7. Second trail eroded to similar stage as old trail. Turf bank separating the two trails is further undercut, becoming unstable. Third trail (C) begins.

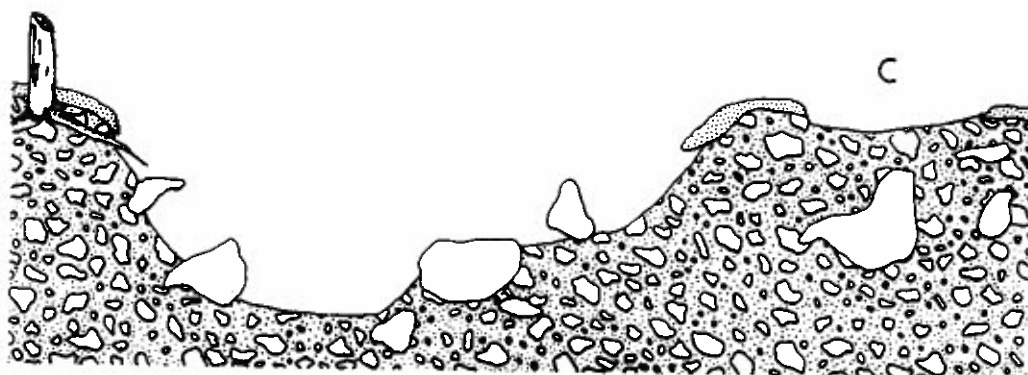
Figure 8. Turf bank collapses and is washed out by running water leaving large rut. Third trail begins to erode.

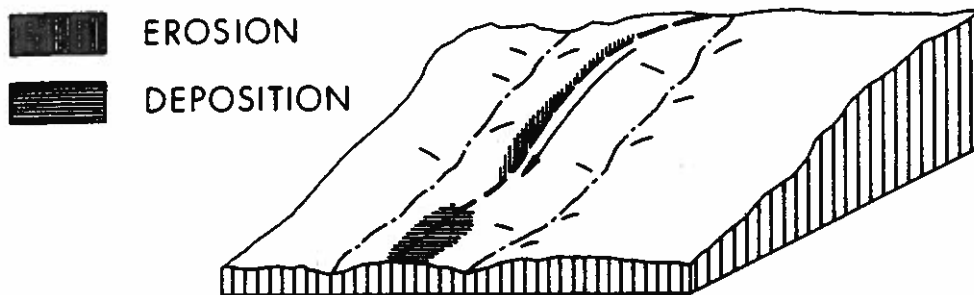
Figure 9. Effect of slope on trail erosion. Trail extends straight downslope, providing an ideal channel for running water.

- (c) Water bars should be used to divert water from steep portions of the trail.
 - (d) Trails should not be constructed running straight downslope.
 - (e) Trails should be constructed so that they will not cause rerouting of streams.

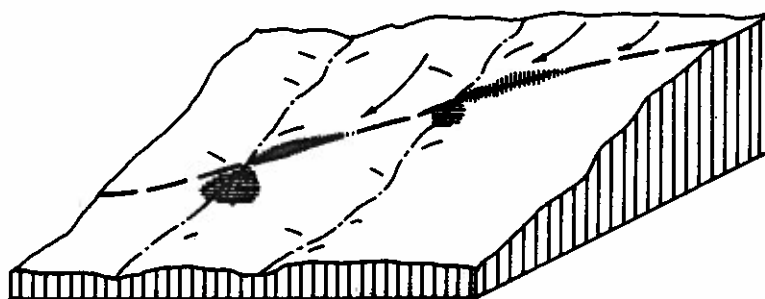
In figure 10, although the trail angles across the slope, some runoff is channelled down the trail, causing erosion in areas above stream intersections with concomitant deposition along the watercourses below.

Figure 10. Effect of slope on trail erosion. Although trail angles across slope, some runoff is channelled down the trail. Each section of trail above stream intercourses is eroded and the sediment deposited in the stream bed below.

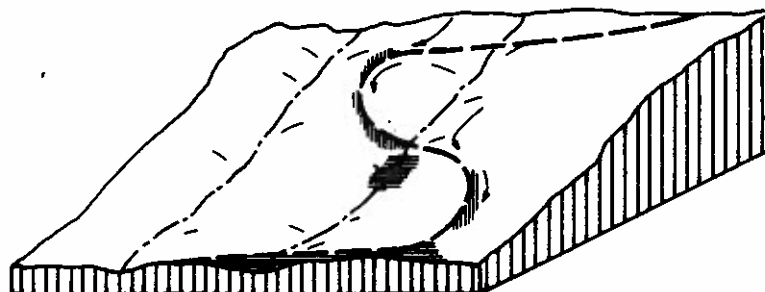
Figure 11 and plate 6 show the effects of poorly constructed switchbacks which have been built in some areas. For example, in figure 11, the bends are not sufficiently sharp to compensate for running water, and the straighter, downslope portions of the trail have been eroded.

Figure 11. Effect of switchbacks on trail erosion. Poorly constructed switchbacks permit erosion by running water similar to that shown in figure 10.

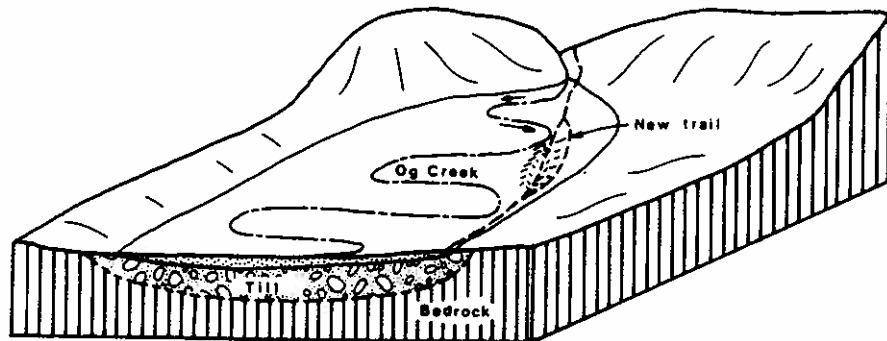
Figure 13. Trail is eroded by water creating a deep rut adjacent to meander in stream bed. New trail developed along lip of rut.

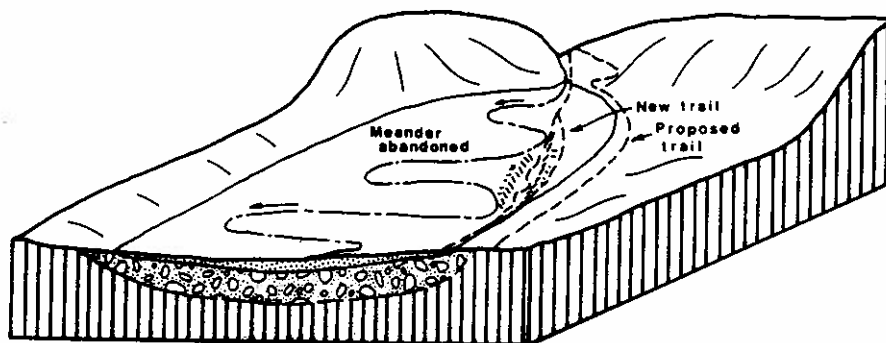
Figure 14. Stream bed is breached by erosion and rut becomes a major channel of Og Creek. The preferred site for a trail through this area is on high ground above the easily eroded alluvial plain.

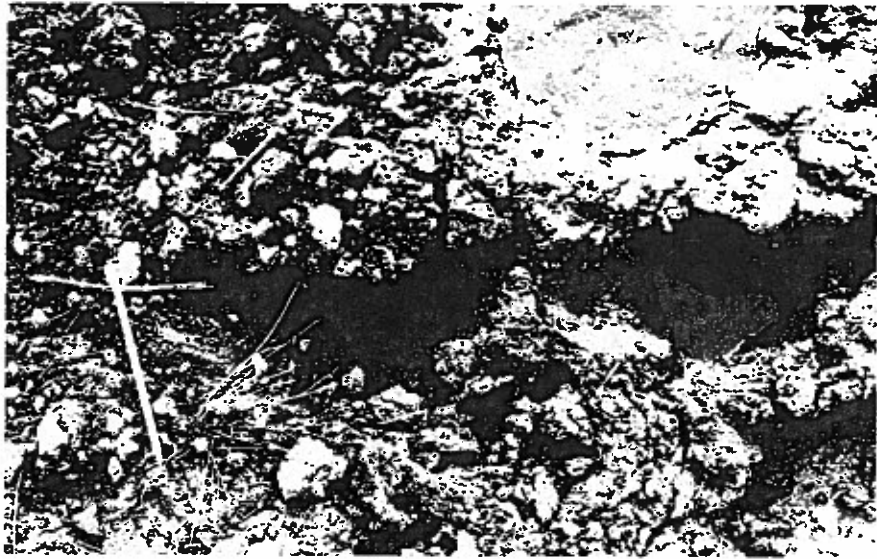
Trampling of wet sections of the trail by horses and humans is the initial cause of trail damage (Plate 1). The thin but coherent vegetative mat which helps bind the underlying soil is breached or worn away by constant use, and relatively unconsolidated surficial materials are thus exposed to churning and compaction, and to the effects of running water and wind.

PLATE 1. Complete destruction of vegetation by trampling.
Note pencil for scale.

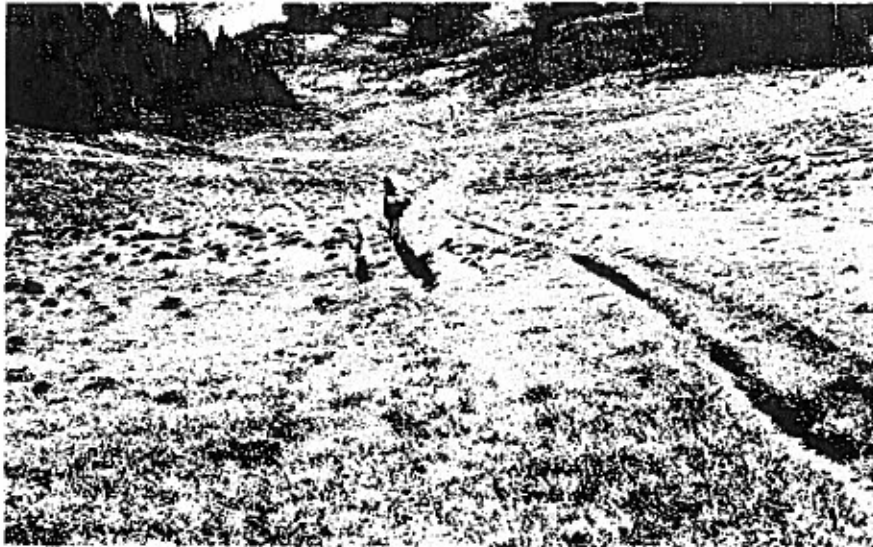
Most trampling effects were observed along streambanks, slopes and in enclosed basin structures (Plate 2). By simply locating the trail above springs or discharge areas and by avoiding enclosed basin structures, this type of damage can be avoided.

PLATE 2. Abrupt rut entrenchment associated with an enclosed basin.

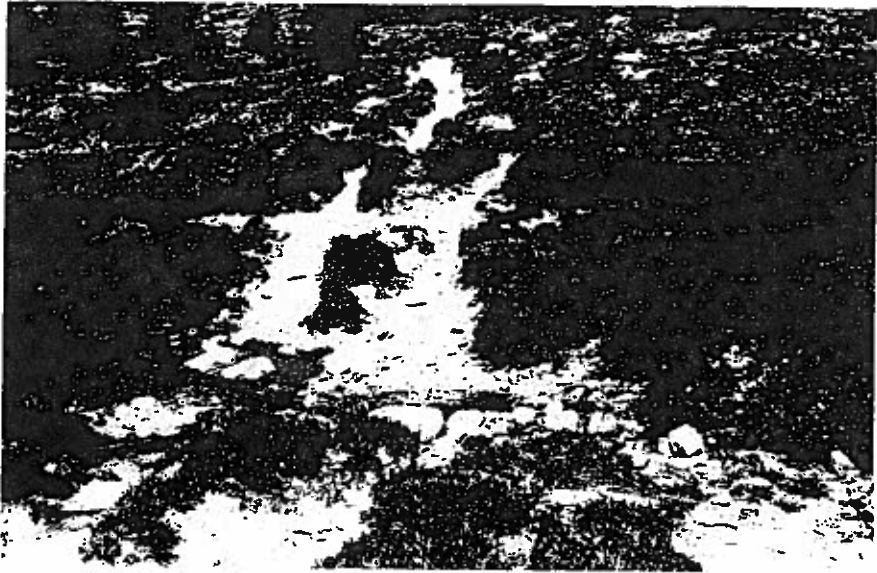
Running water is the principal agent of observed trail erosion. Water running across, along or in close proximity to the trail erodes fine particles, exposes roots and rocks, and undercuts vegetation adjacent to the trail (Plate 3). Table 4 shows the percentage of observations of trail erosion by running water on various parent materials.

PLATE 3. Trail damaged by running water.

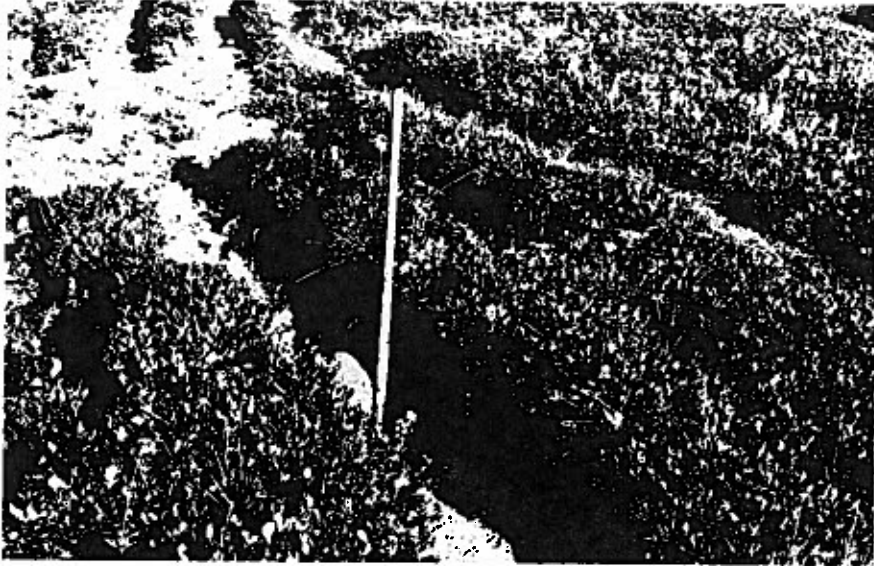
Sand and silt removed by running water normally are deposited downslope and thus create ideal conditions for further damage by trampling. In places much of the trail has become so rutted that new trails have been worn parallel to the old (Plate 4). In extreme but not uncommon cases, streams have abandoned their channels and now flow down parts of the trail (Plate 5).

PLATE 4. New trails worn parallel to old trails.

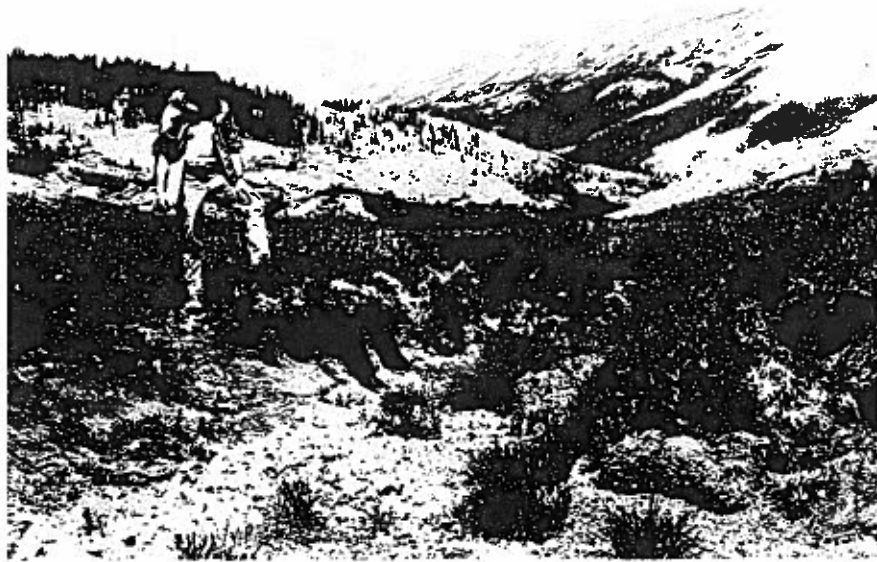
PLATE 5. Trail completely destroyed by running water.

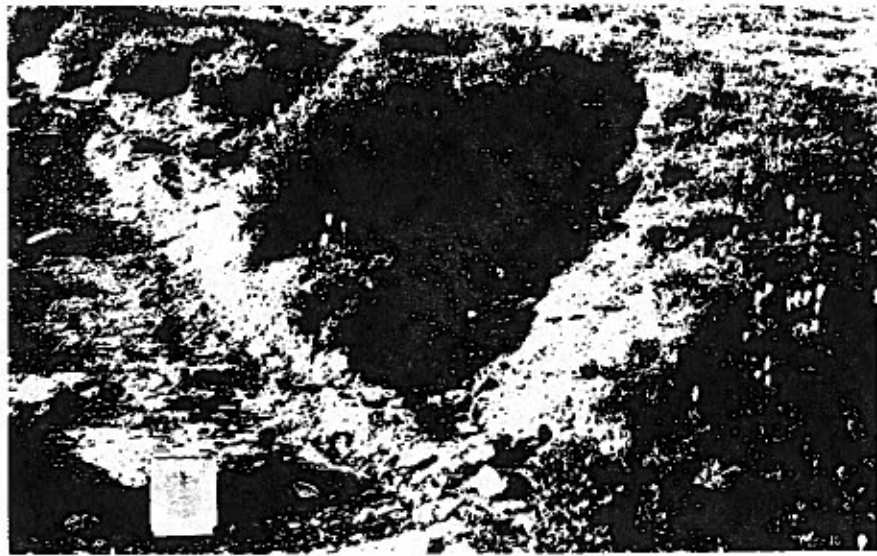
PLATE 6. Poorly constructed switchback leads to trail erosion by running water.

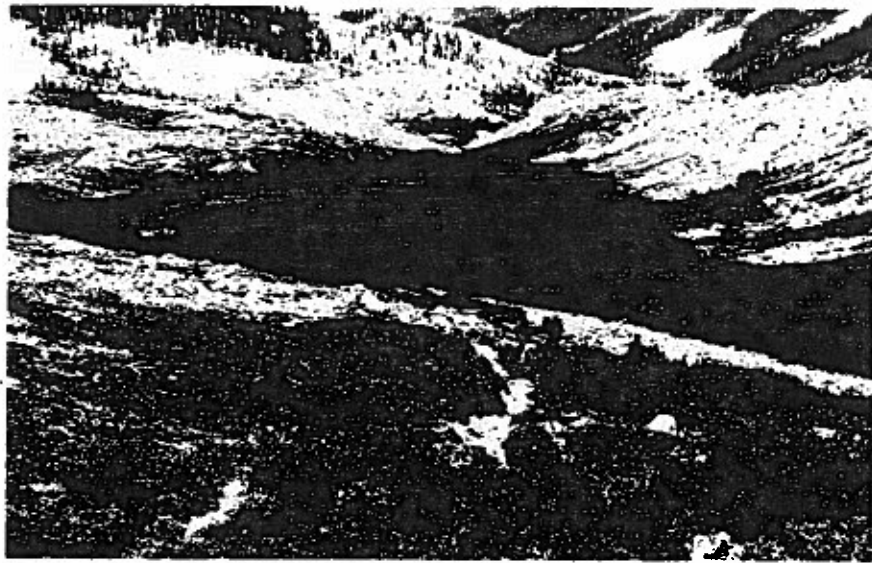
The plain immediately south of Og Lake (Plate 7) provides a good example of the potential hazards to be found in such areas. The original trail was built straight across the plain, i.e., parallel to the regional slope, being located close to one of the meanders of Og Creek (Fig. 12). With time, horse and foot traffic compacted the soil until a rut was worn. At the same time, Og Creek gradually eroded the outside meander bank and cut into the trail rut, which provided a more direct route down-slope, and streamwater flowed down the trail (Fig. 13). Subsequent annual erosion has removed so much material from the original rut that the trail is now the major channel of Og Creek (Plate 8). The new trail, built immediately to the west of and parallel to the original trail, soon will be incorporated as Og Creek erodes laterally (Fig. 13).

PLATE 7. Alluvial plain immediately south of Og Lake which has undergone extensive soil erosion. Original trail extended through the plain at the left of the photograph.

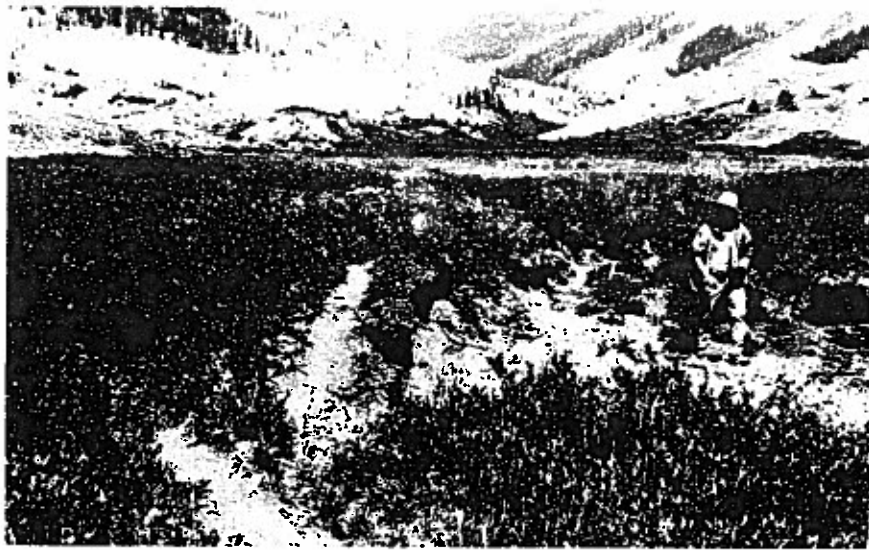
PLATE 8. Hiker walking in the major channel of Og Creek developed by erosion of the original trail rut.

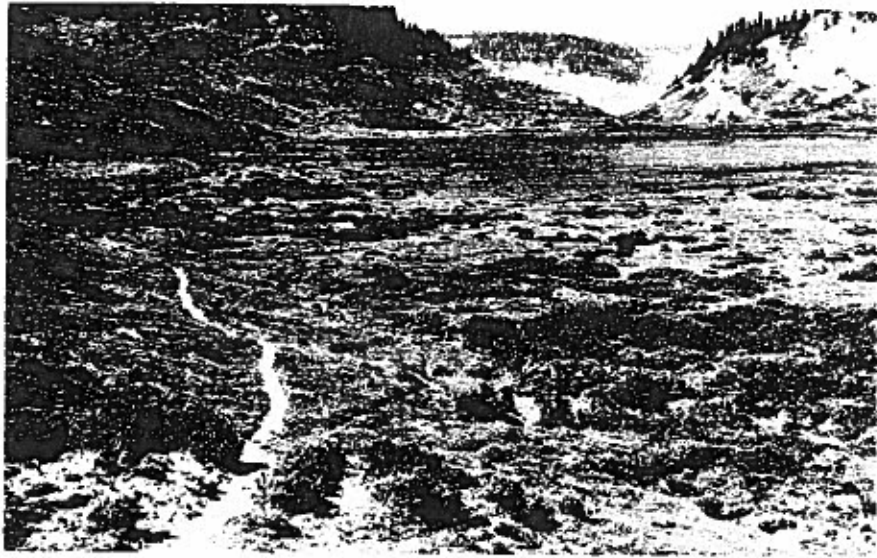
This type of trail damage has occurred to a lesser degree in each of the alluvial plains between Og Lake and Wonder Pass. In each case, placing of the trail on the side slopes above the plain would avoid such damage (Fig. 14 and Plate 9).

PLATE 9. Trail in good condition on side slopes above an alluvial plain.
