GEOLOGIC FACTORS AFFECTING LAND DEVELOPMENT
AT FORT MCMURRAY, ALBERTA

C.P. Kathol and R.A. McPherson¹

Research Council of Alberta
11315 - 87 Avenue
Edmonton, Alberta
T6G 2C2

1973

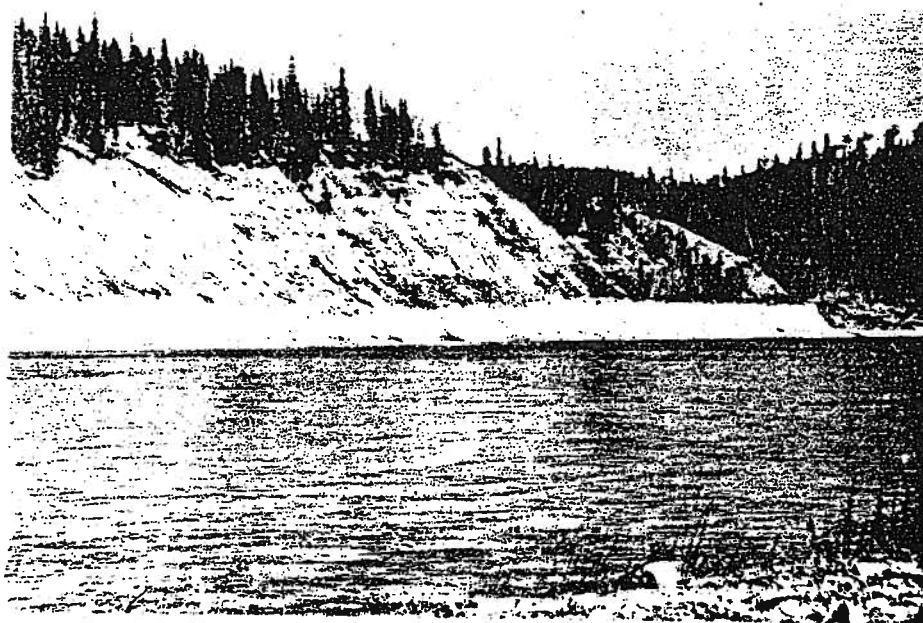
Figure 4. Deformed contact between the Beaverhill Lake Formation and the overlying McMurray Formation.

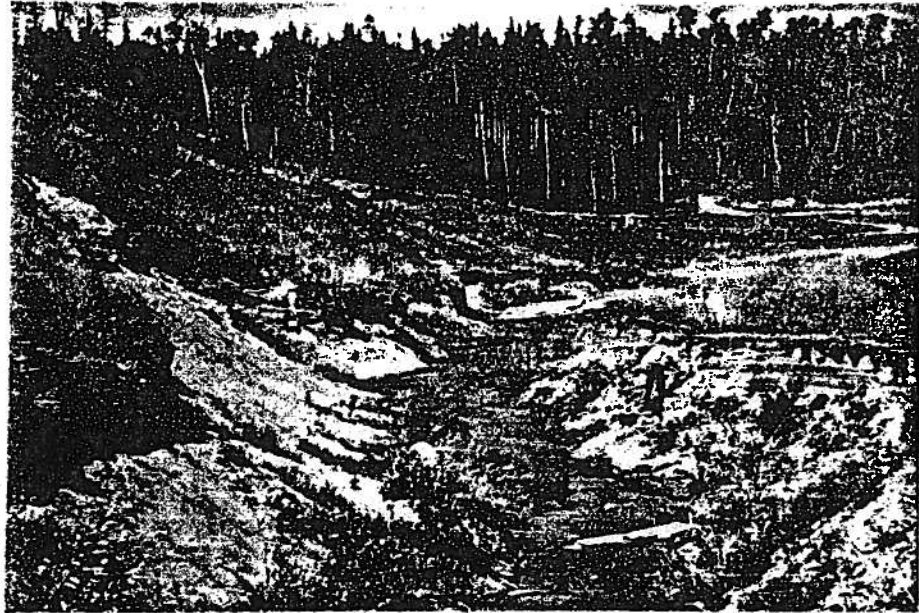
Wherever vegetation was absent along slopes, erosion of the surface deposits was prevalent. Extensive gullying was observed throughout the area and appeared to be most common in unconsolidated sands. An example is shown on Figure 6 where surface runoff has eroded a major gully in river terrace sands on the west bank of the Athabasca River.

Figure 6. Extensive gulying in river terrace sands along the Athabasca River caused by surface runoff (west side of bridge on the Athabasca River - north of Fort McMurray).

(1) All types of geologic deposits in the area, with the exception of the Beaverhill Lake Formation and Athabasca oil sands, are susceptible to erosion and gullying on steep slopes when the vegetative cover is removed. Therefore, when any development is planned near any slopes, vegetative cover should not be removed if possible. Roadcuts, etc. should be revegetated as soon as possible.

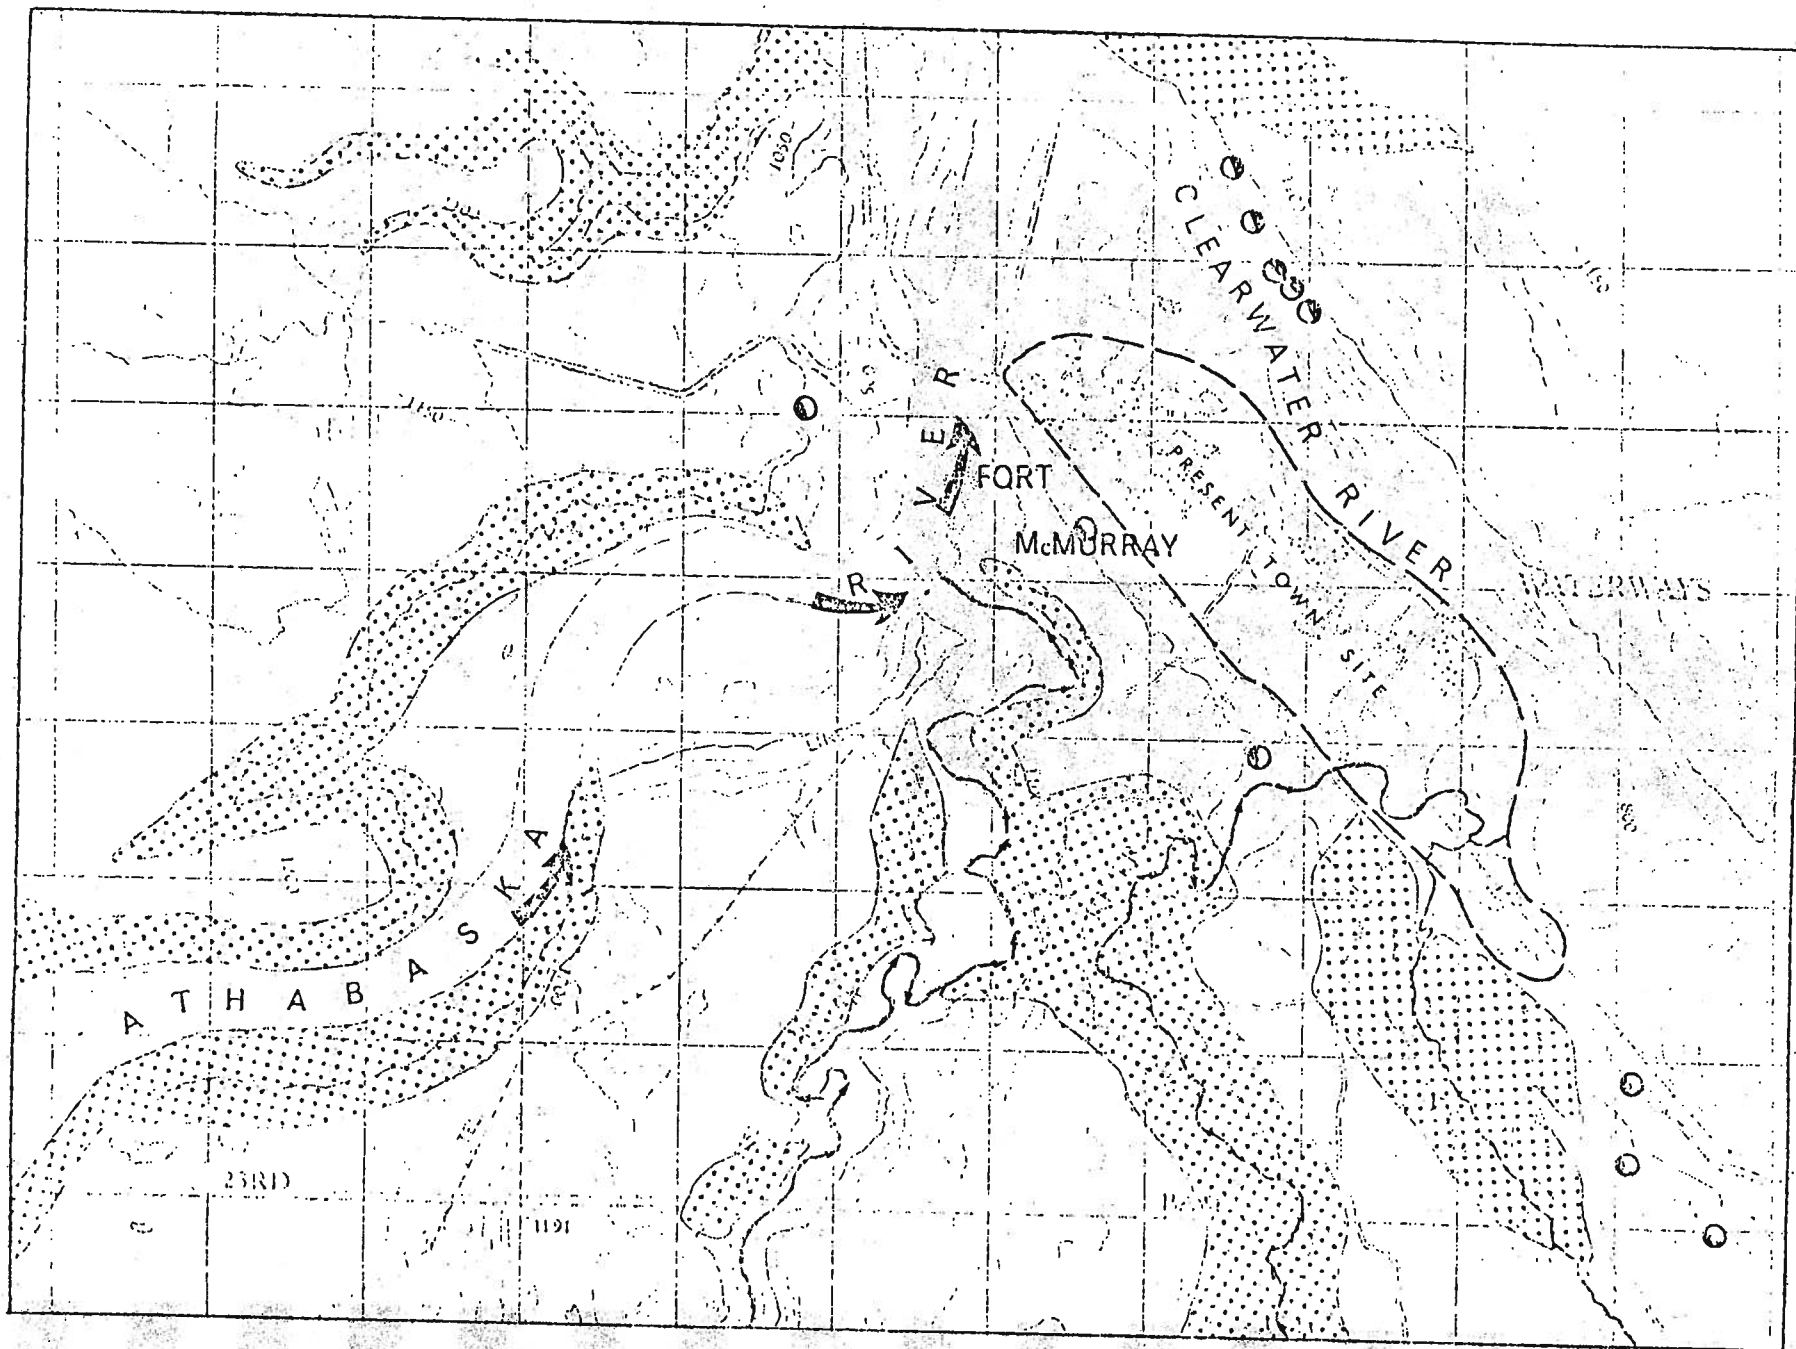
Figure 7

Extensive slumping present: bank is generally unstable.

Individual slump: not within an extensive slump area; bank appears to have more stability.

Active undercutting taking place: steep unstable banks above.

There are numerous other slumps and landslides along all of the stream valleys in the area. Areas where they have been observed on air photographs or in the field are outlined on Figure 7.

(2) Development should be avoided near banks presently being undercut by streams. These areas have been outlined on Figure 7.

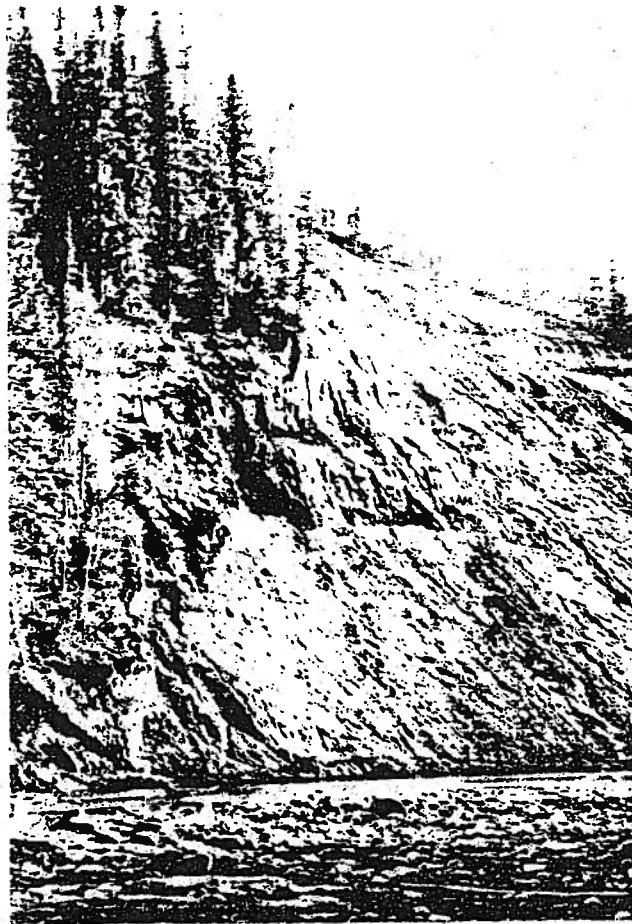
Undercutting is common along the inside of meanders on all the streams in the area. Stream erosion of material at the toe of the slopes results in instability of the overlying banks. Generally these areas are predominated by bedrock outcrops because active erosion prevents the development of vegetative cover. Areas where active undercutting is taking place are outlined on Figure 7. The McMurray Formation does not appear susceptible to massive slumping and landslides and usually forms steep banks (Fig. 8).

Figure 8. Steep exposure of McMurray Formation being undercut by the Hangingstone River at Fort McMurray.

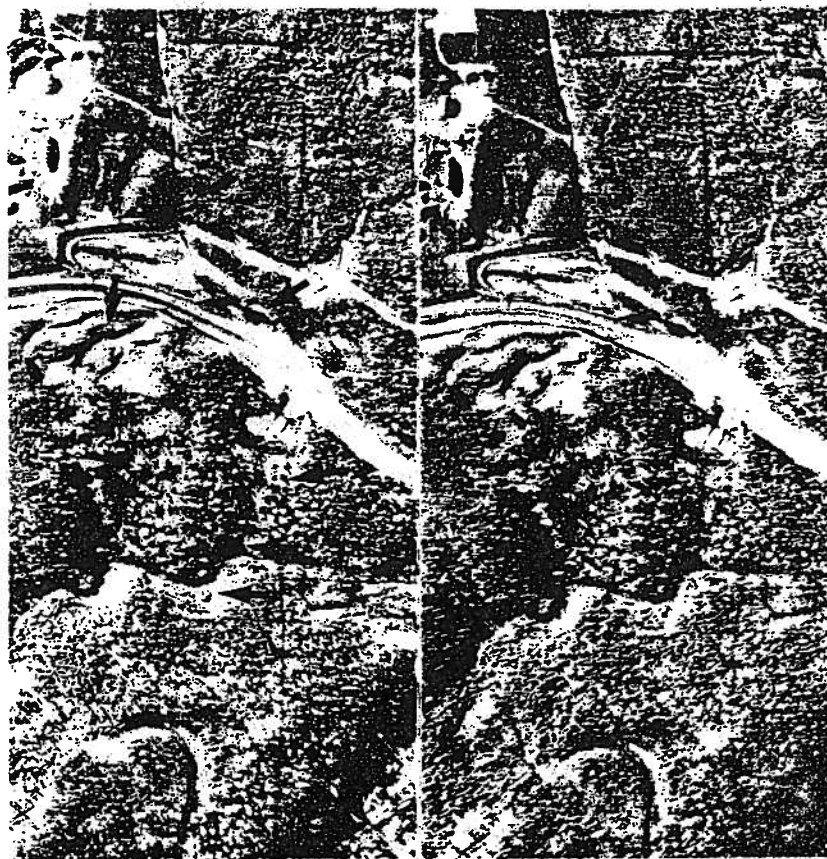
Landslides are present on Highway 63 along the bank of Saline Creek south of Fort McMurray. An air photo stereopair of the slides (Fig. 9) shows major arcuate slip faces in the bedrock and fallen and bent trees caused by downslope movement of a large landslide. A smaller slide has occurred on the opposite side of the highway as well. Removal of vegetation and oversteeping of the bank during road construction appears to have caused the slide. Failure has occurred in the Clearwater shale as illustrated on Figures 10, 11, and 12. Slumping is apparent near the top of the slide and flowage is present at the toe. No groundwater springs were observed in the vicinity of the slide. Gullying of the shale caused by surface water runoff is also prevalent in the roadcuts because vegetative cover is absent.

Figure 9. Stereopair of landslides on Highway 63 south of Fort McMurray. Note arcuate slip faces and bent and fallen trees associated with the slide.

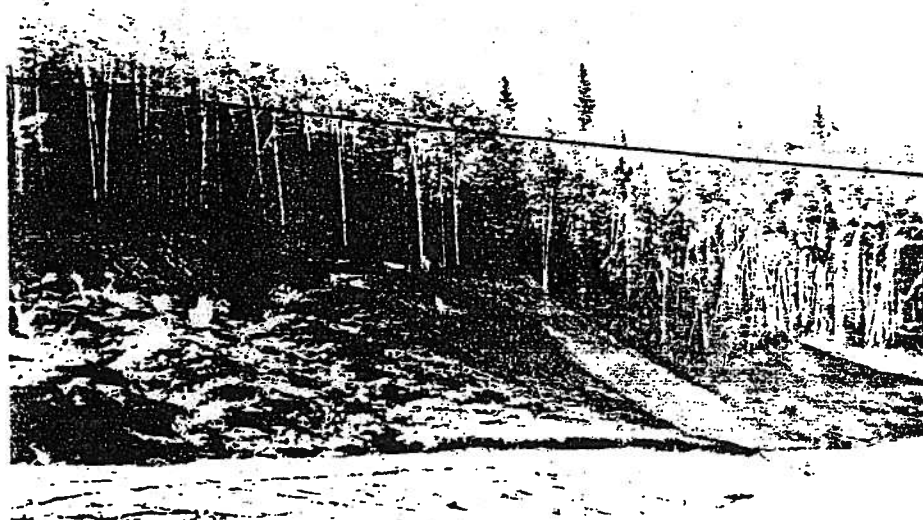
Figure 10. Landslide in Clearwater shales on Highway 63 local cut south of Fort McMurray.

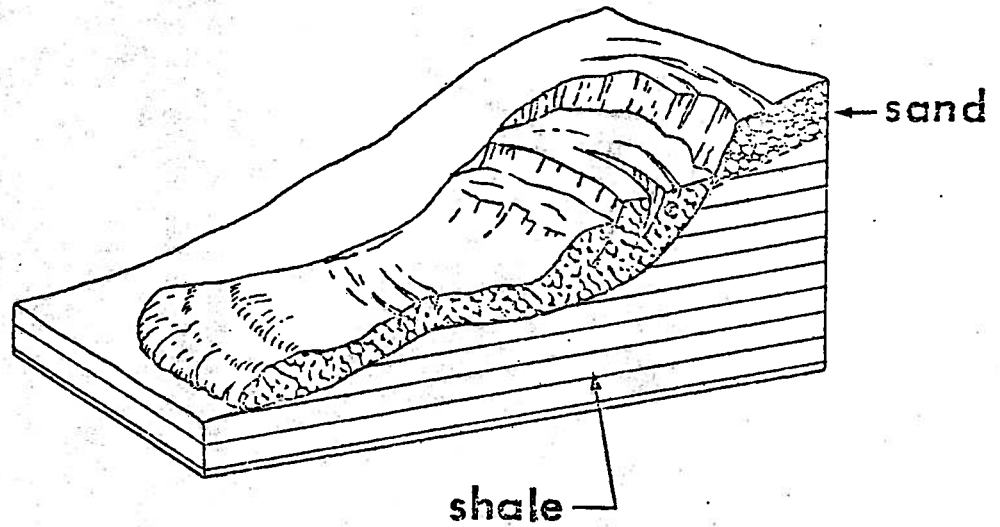
Figure 11. Schematic diagram of landslide shown in figures 10 and 12.

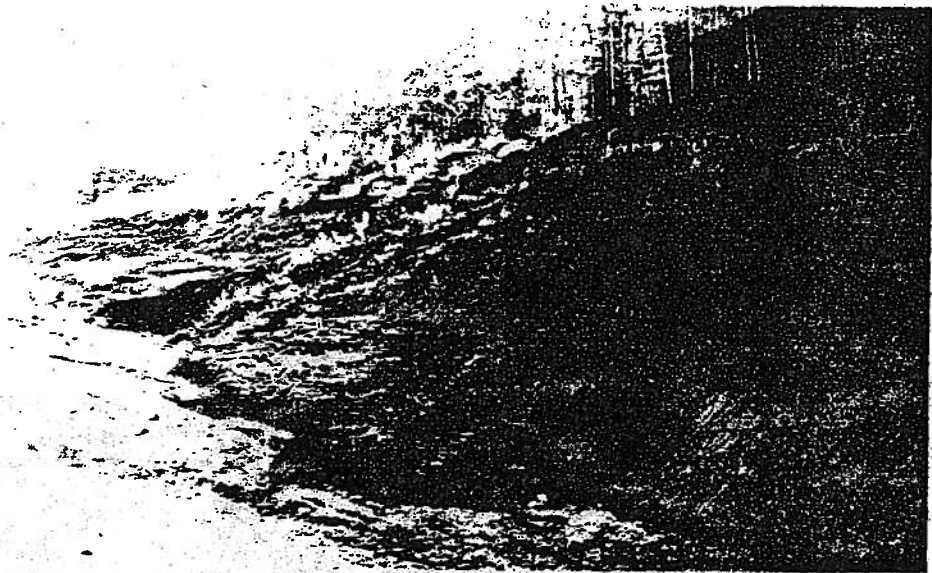
Figure 12. Landslide in Cretaceous shales on Highway 63 road cut south of Fort McMurray. Note the slip scars at the top of the landslide and the flowage at the toe. Also observe the gullying below the toe of the slide.

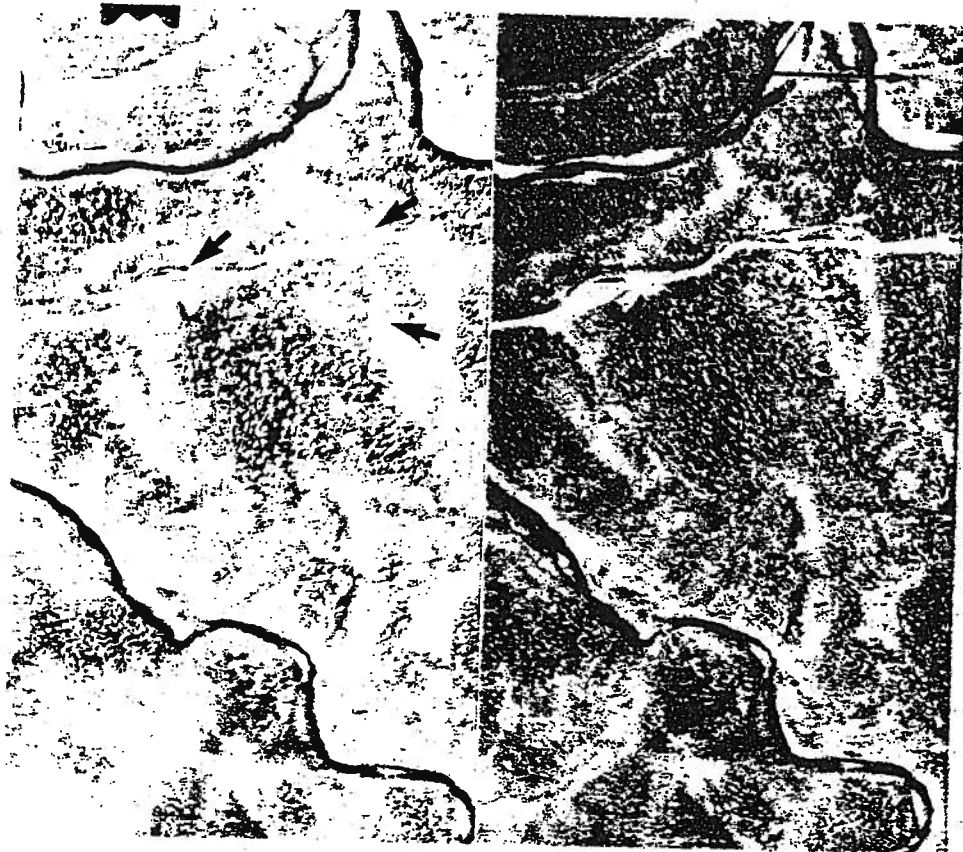
Another well developed series of landslides occurs along a road between the Horse and Hangingstone Rivers south of Fort McMurray (Fig. 13). All the slides occur in the Clearwater shales and no groundwater springs are present. At one locality, the road has been constructed on a major slump block; a second slump block also occurs above the elevation of the road (Fig. 14). Below the roadcut, the trees are fallen and bent because of downslope movement toward the Hangingstone River (Fig. 15).

Figure 13. Stereopair illustrating landslides on a road between the Horse and Hangingstone Rivers south of Fort McMurray.

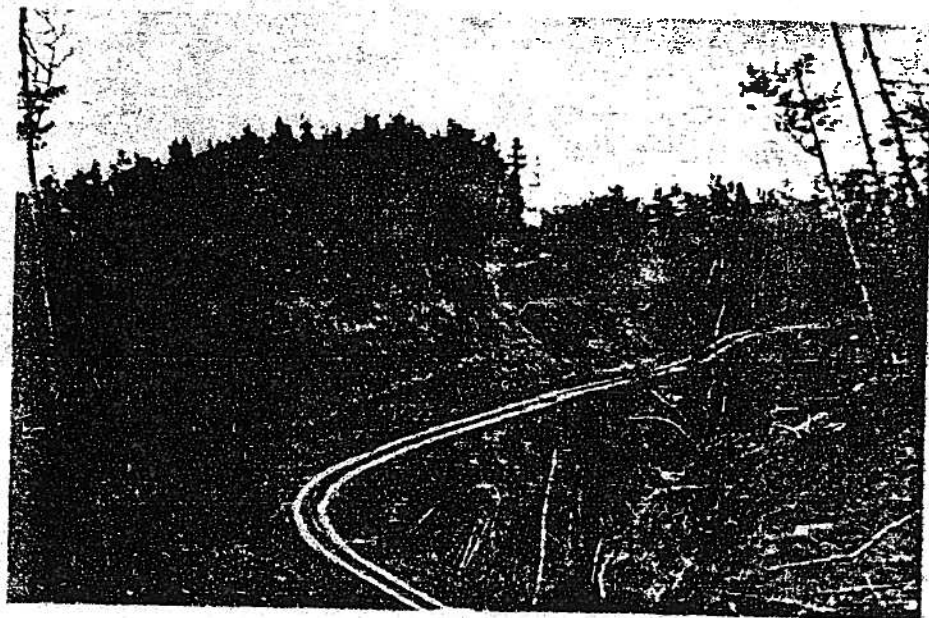
Figure 14. Landslide in Clearwater shales; the road is built on a slump block

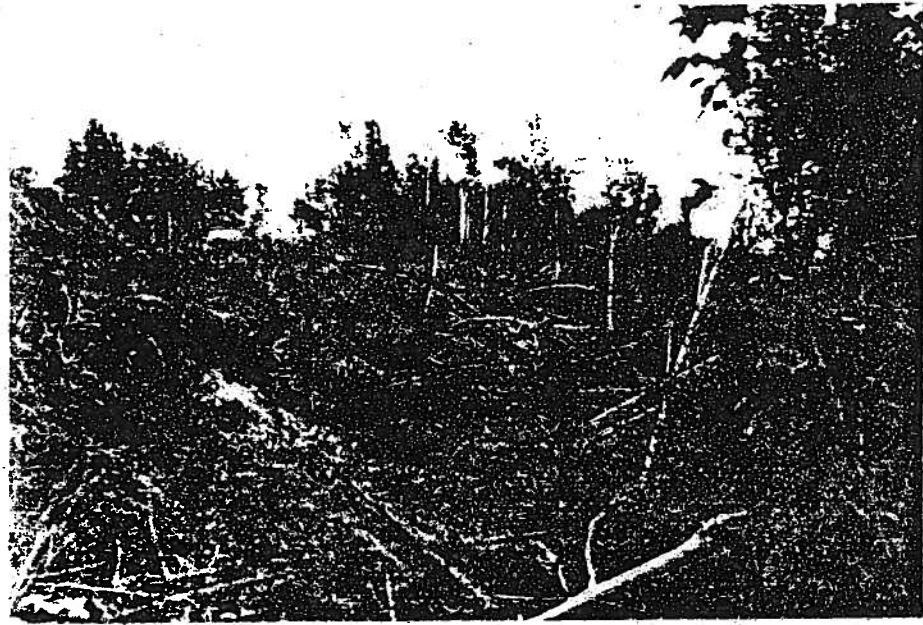
Figure 15. Fallen and bent trees caused by downslope movement caused by a landslide in Clearwater shales. The slump block shown in figure 14 is to the right of the photograph.

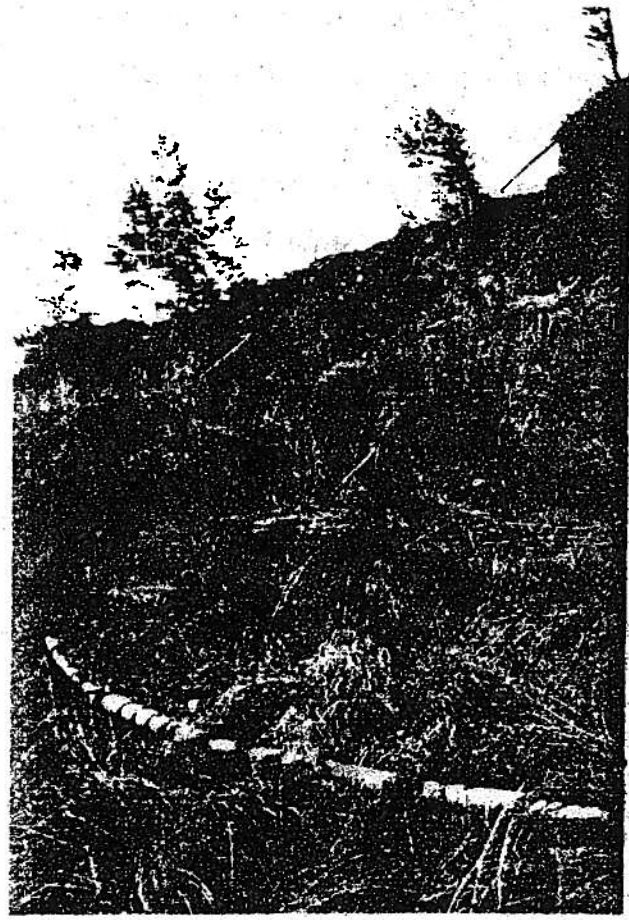
Another landslide, immediately to the south has exposed and bent a gas pipeline because of downslope movement toward the Horse River (Fig. 16).

Figure 16. Clearwater shales eroded by running along the side of the River. The

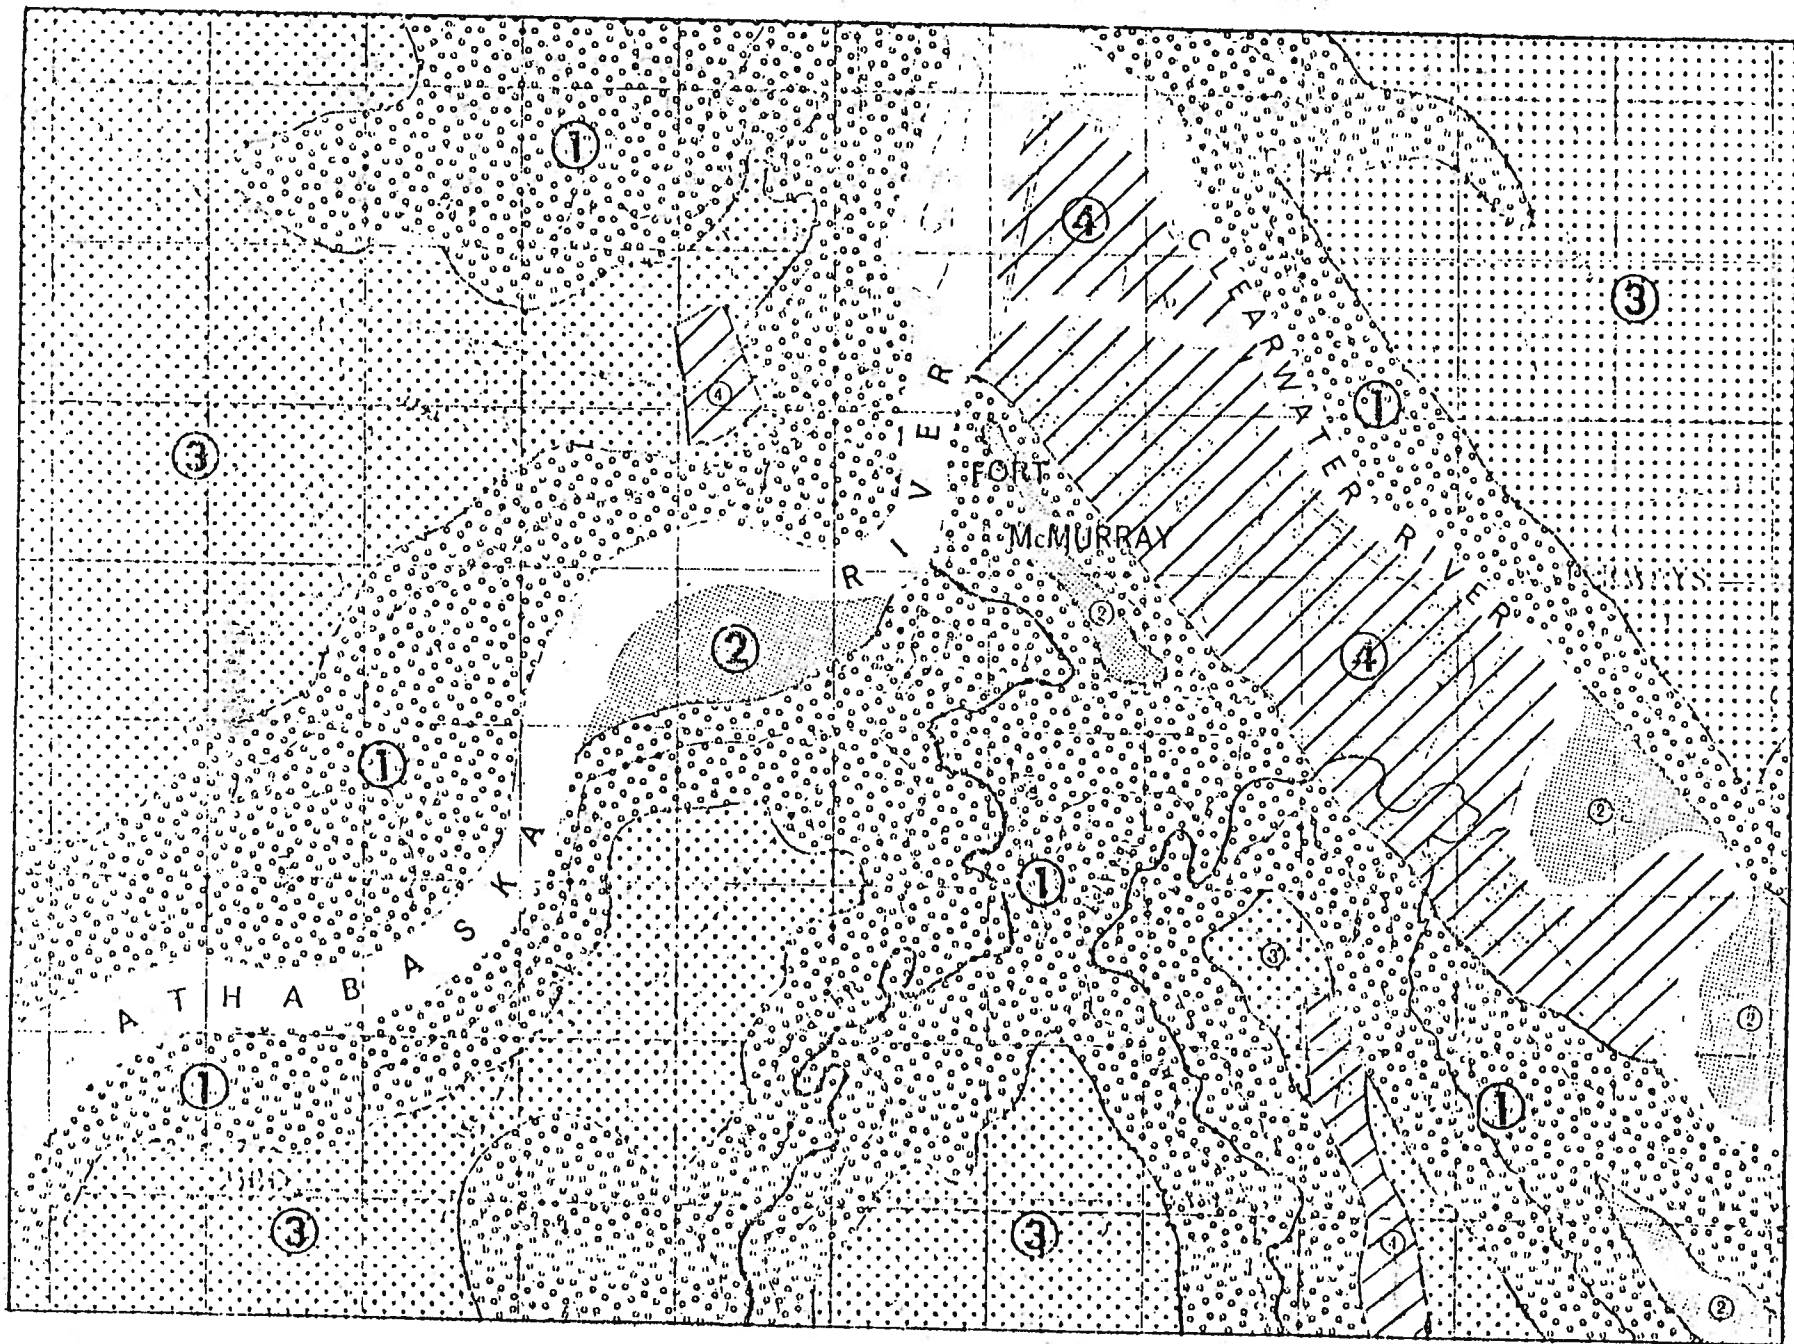
Figure 17

(3) A generalized map of areas that are suitable for future development in terms of slope stability is provided on Figure 17. Area (1) consists of unstable areas susceptible to undercutting by streams, landslides, and slumping.

Area (2) consists of terraces along the Athabasca and Clearwater Rivers. These areas should not have slope stability problems; however they are relatively small and inaccessible from the present townsite.

Areas labelled (3) are stable uplands that appear suitable for land development in terms of slope stability. However, a survey of other potential geologic problems in these areas would be required to determine their suitability for development. In addition, most of the areas are underlain by potentially economic oil sands deposits and the alternatives of oil sand exploitation or land development would have to be considered.

Areas labelled (4) are currently developed and appear stable in terms of slope stability. There is limited space for further development in these areas. The practice of building along the unstable slopes of the Clearwater River above the present townsite (as has occurred in a few instances) should be clearly avoided.

Unstable area: should remain undisturbed.
