GEOLOGICAL REPORT

RIVER BANK STABILITY STUDY

UNIVERSITY OF ALBERTA

M. A. ROED

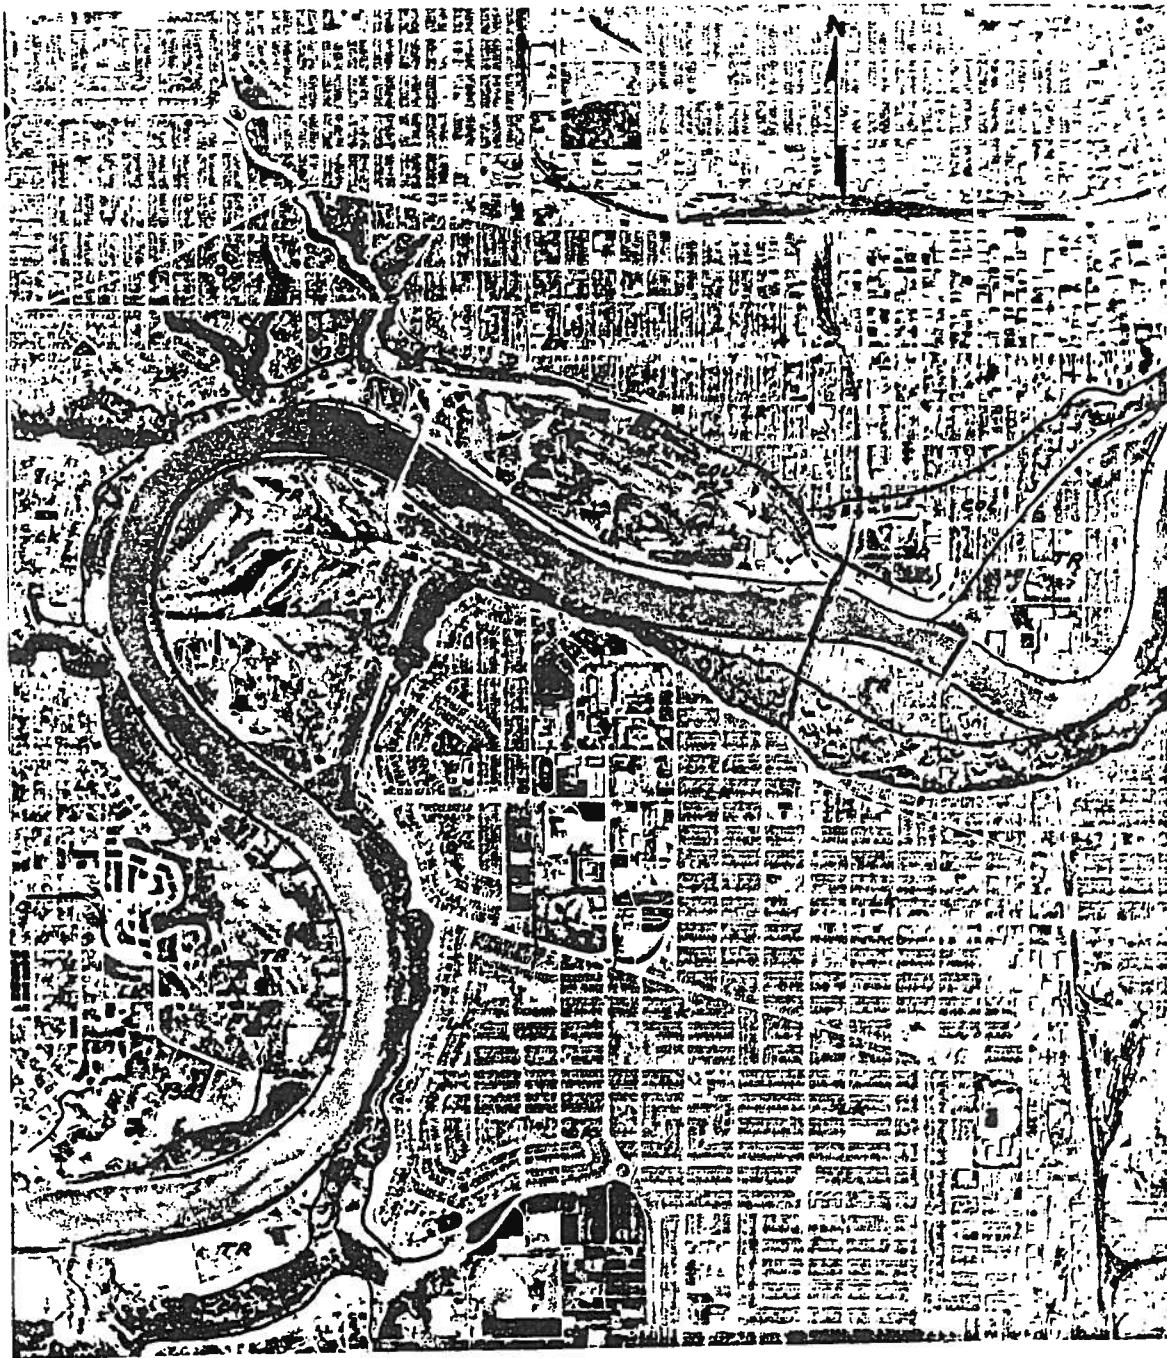
PLATE I

GENERAL SURFICIAL GEOLOGY

LK	Lacustrine Deposits	~	Slump Topography
↖	Erosional Scarp	⋯	Positive Surficial Anomaly
↔	Break in Slope	---	Contact (defined approximately)
TR	River Terrace	col	Colluvial Deposits
SS	Slip-off Slope

the geomorphic units in the area. An aerial photograph mosaic was used as a base map for compilation of the data. (Plate 1).

All lithologic details of deposits described in field localities are recorded in Appendix A and those encountered in test holes in Appendix B. The aerial photograph mosaic (Plate 1) and the geologic map (Figure 1) show the distribution of deposits described in the report. The cross sections (Figure 2) show the subsurface conditions. Reference should be made to these illustrations to facilitate understanding the information presented in the report.

plain is featureless except for a very low broad topographic rise trending north-south (Figure 1 and Plate 1). Subsurface information indicates that this rise is the topographic reflection of an extensive glacial sand deposit which has been nearly obscured by later (and in part contemporaneous) deposition of lacustrine silts and clays. The deposits are discussed more fully in another part of this report.

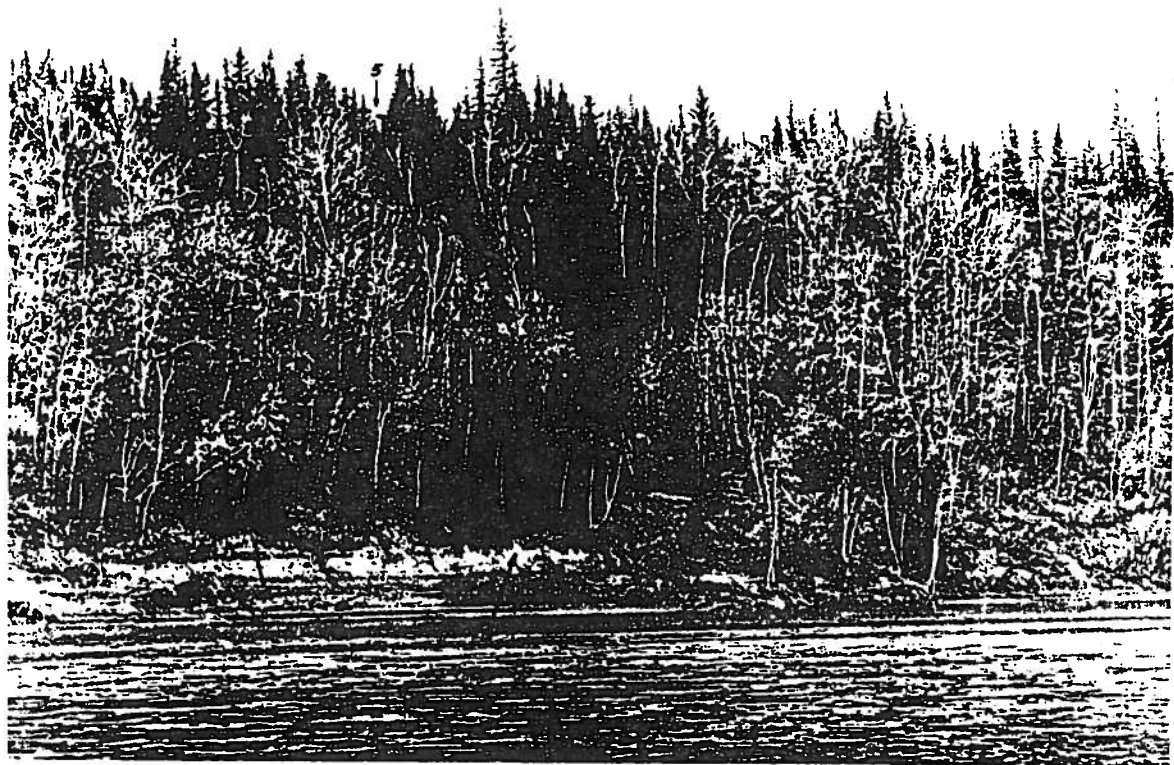
*PLATE 2*

Sedimentary rocks of Upper Cretaceous age crop out for a short distance along the river bank (Plate 2) and belong to the Edmonton Formation. The regional dip is about 20 feet to the mile towards the southwest (Bayrock and Hughes, 1962, p. 16). The strata consist of interbedded grey shale, grey sandstone, greenish grey bentonitic sandstone, coal and bentonite.

The landslide at locality 2 (Plate 2) is described in detail in Appendix A. It is a combination rotational slump and mudflow, mostly in bedrock, in which occurs a thin band of bentonite, but the lower part of the Saskatchewan sands and gravels is also involved (see locality 6, Appendix A). Along the top of the Edmonton Formation from locality 2 east to locality 4, the ground was observed to be very wet, with pools of water in places; this water is groundwater discharge from the buried valley that is located beneath the campus. This slump is believed to result in part from undercutting of the bank by river erosion and in part from the observed ground water discharge.

<u>Lithologic Description</u>	<u>Thickness (feet)</u>
Soil profile and colluvium.	2 1/2
Bentonitic sandstone, soft (whitish band in Plate 2).	1 1/2
Interbedded shale and soft sandstone, 2-4" bentonite near top of section - To west bentonite associated with pink (?burnt) shale and with a coaly shale.	13

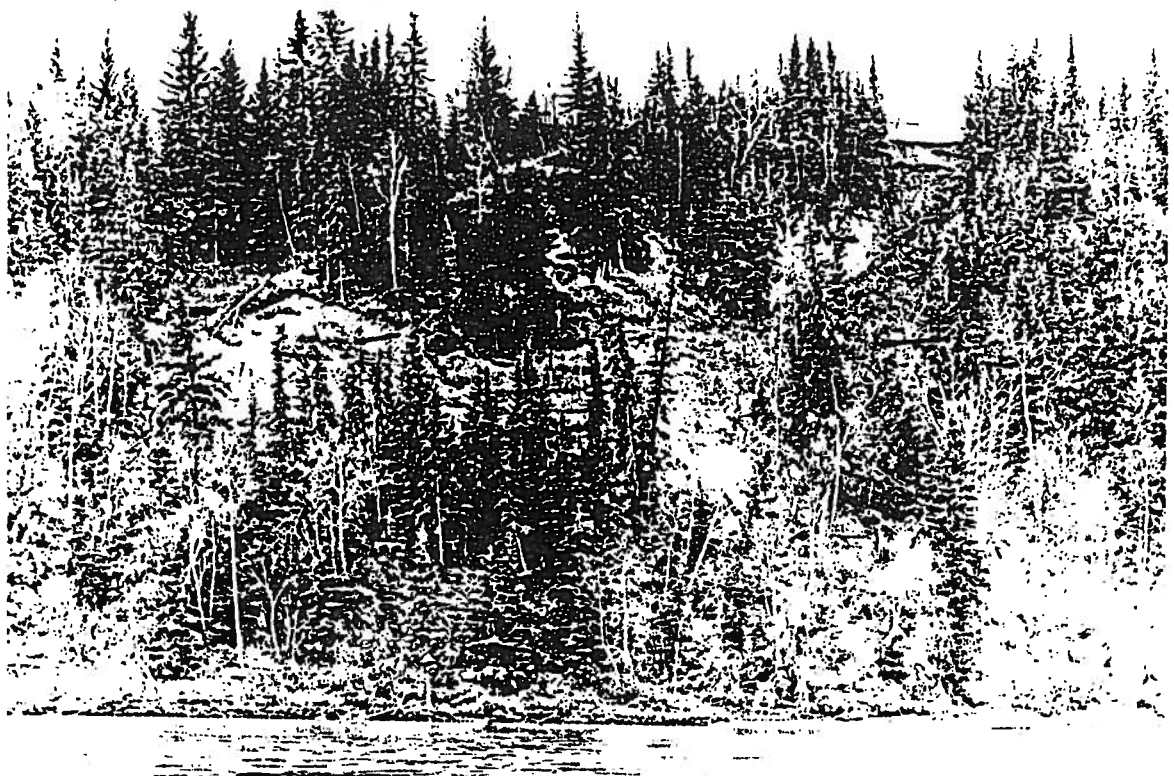
*PLATE 3*

Plate 3 View looking south from the north side of the river showing gully that is directly north of the parking lot (Figure 1, Locality 3).

- (1) Gully channel filled with debris of fresh landslide;
- (2) Scarp of landslide;
- (3) Sand run in glacial outwash sand associated with lacustrine deposit;
- (4) Scarp of small landslide in till;
- (5) Small terracettes developed by human traffic or soil creep processes in sand of Saskatchewan sands and gravels.

At locality 3, the upper part of the gully failed by slumping and initiated a narrow confined earthflow that travelled down slope to within 30 feet of the river level.

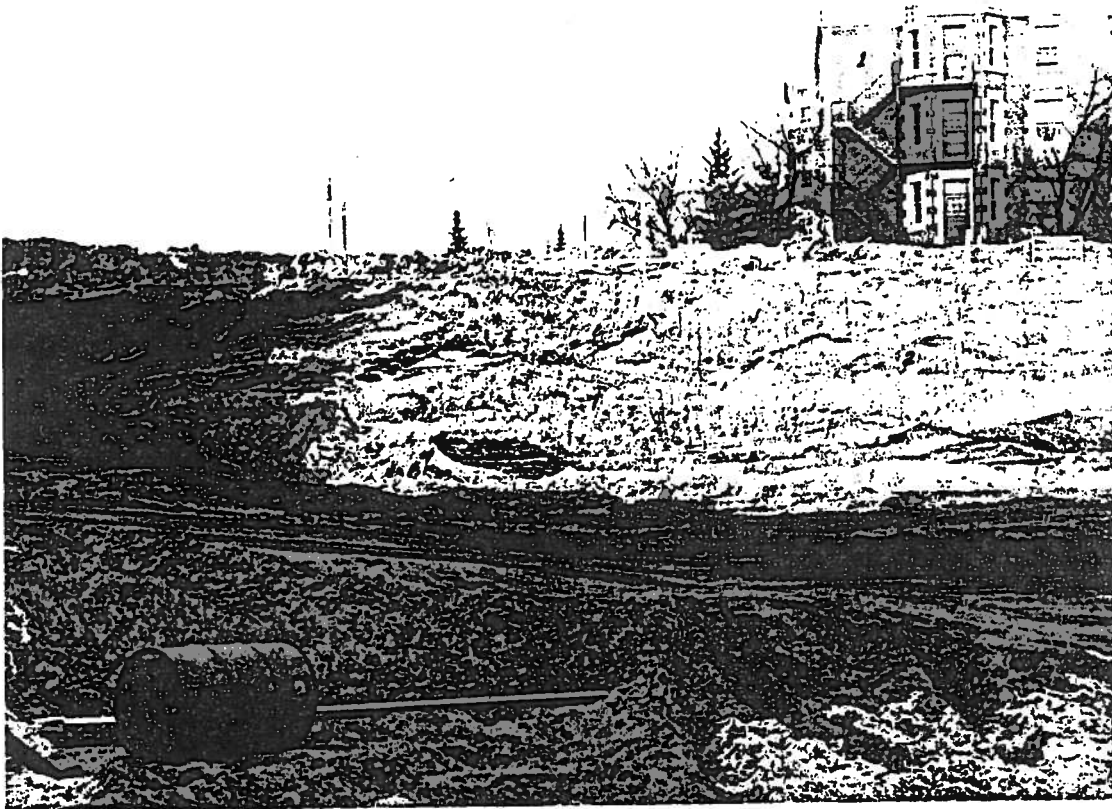
PLATE 4

The sand is very light brown in colour, fine to medium grained, with some pebble bands, thinly to thickly cross-bedded, and of medium density. The maximum thickness is 53 feet in the area of the Administration Building. The sand is thinner to both east and west. The character of the sand was examined in the excavation of the new Students' Union Building (Locality 9) and is illustrated in Plates 4 and 5. Here, as in many of the test holes, a thin layer of till-like material was found to overlie the sand; at depth the sand overlies a thick till. The overlying thin layer of till-like material is here interpreted as being a flow till, derived from a glacier which was very close during the time of formation of the sand deposit. Also at this locality, the upper layers of sand are interbedded with clay and silt layers of lacustrine origin. This indicates that the sand was deposited at the same time as the early deposits of Lake Edmonton. The sand is inferred to be an ice-contact deposit, laid down at the margin of a glacial lake. Cross-beds in the sand dip gently (about 5°) to the south at locality 9, indicating a southerly flow to the current which deposited the sand.

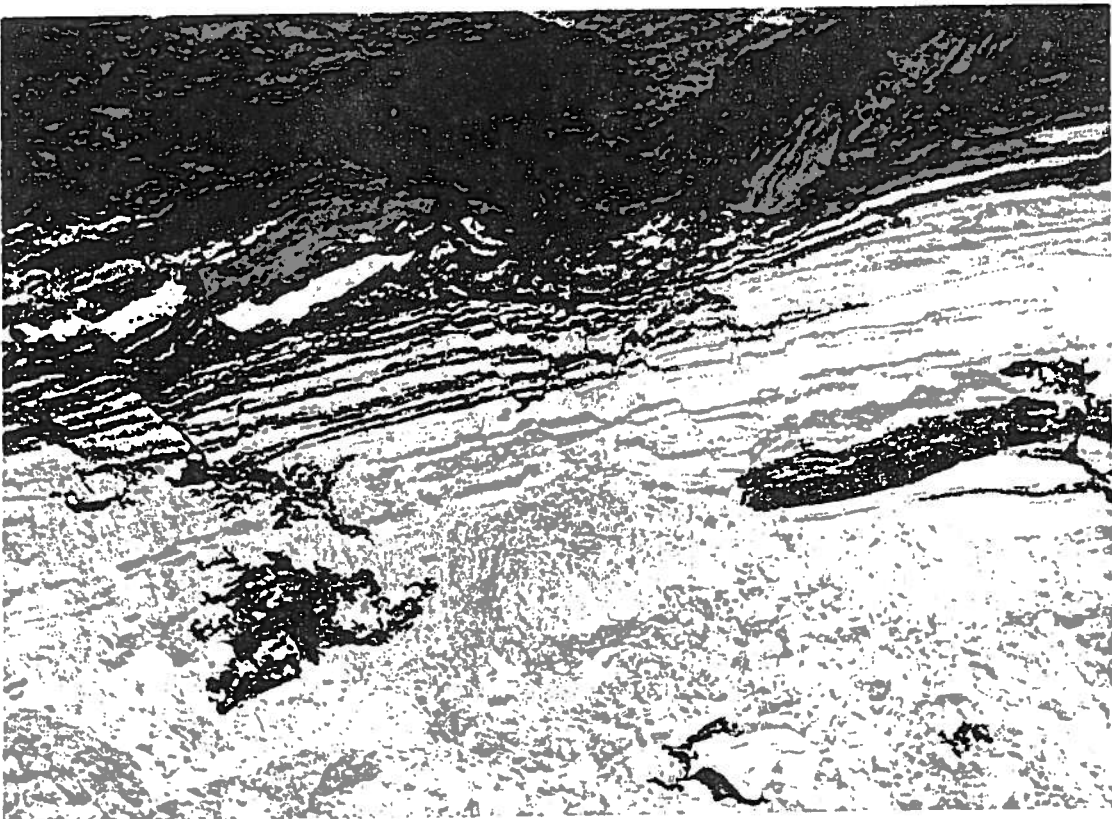
PLATE 5

Plate 5 Close-up of 3 in Plate 4 showing detail of contact between lacustrine clay (dark sediment on top) and ice-contact shallow-water bedded sand and clay (light coloured at bottom).

- (1) Small low-angle reverse fault;
- (2) Small graben structure;
- (3) Tongue of clay protruding through bedded sand. All these features are typical of ice-contact sediments;
- (4) Lacustrine clay in which thin discontinuous bands of till occur.

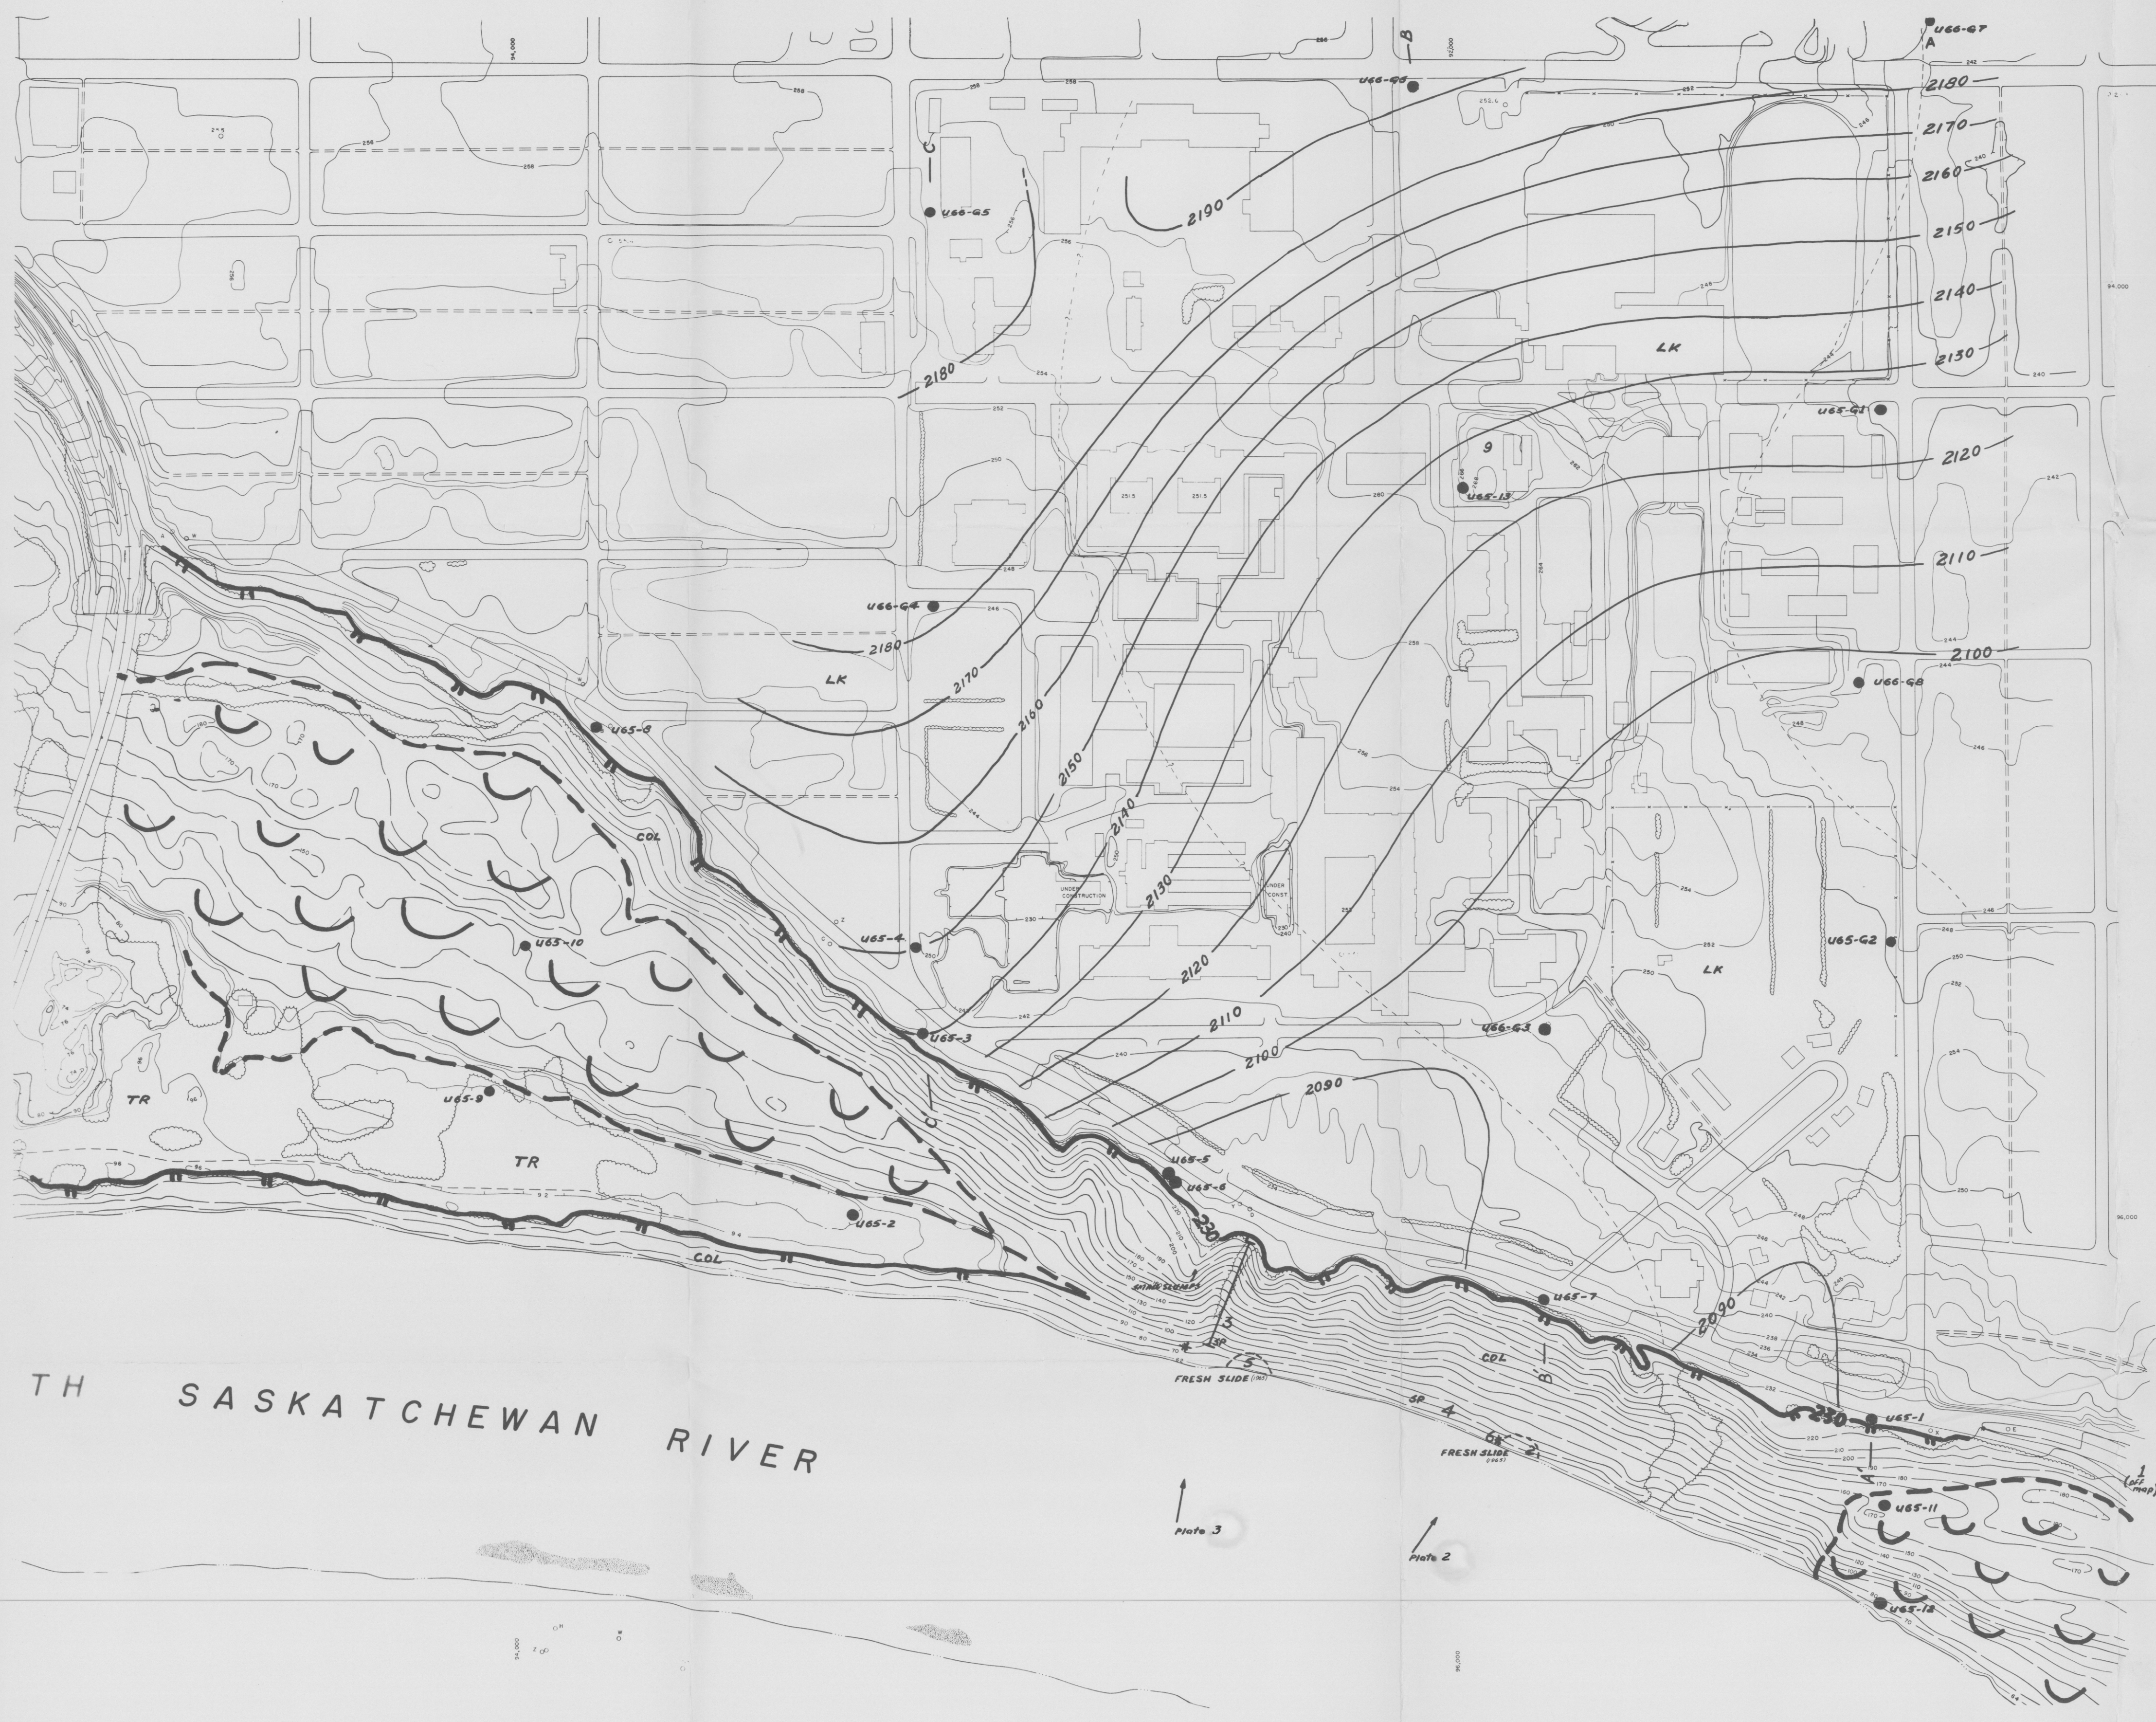
FIGURE 1  
GEOLOGIC MAP  
LEGEND

Scale: 1" = 200 FEET

A. S. PROJECT NO. 14/65  
Compiled by Photogrammetric Methods from Air Photographs taken in 1962.  
AERIAL SURVEYS SECTION  
TECHNICAL DIVISION  
DEPT. OF LANDS & FORESTS  
ELEVATIONS ARE ARBITRARY  
DATED MAY 1965  
CONTOUR INTERVAL - 20'  
OFR 1966-9

A distinctive feature of the valley sides is subdued slump topography. As shown in Figure 1 extensive slump topography is present in the eastern part of the area; a small area of slump topography also occurs in the extreme northwestern part of the map sheet.

The upper surface of the Edmonton Formation ranges in elevation from 2090 to 2190 feet, that is, local relief of the bedrock surface is about 100 feet as shown in Figure 1. This local relief is a direct result of long-continued river erosion prior to the deposition of the Saskatchewan sands and gravels. The northwestern part of the campus is underlain by the east flank of a large buried valley. As a result in some places the Saskatchewan sands and gravels overlie the Edmonton Formation and in other places glacial deposits overlie the Edmonton Formation. This upper contact of the Edmonton Formation is abrupt and defines an erosional unconformity of considerable magnitude.

3. Fresh Landslides: Three small landslides occurred along the riverbank during the summer of 1965 and are referred to as fresh slides (Figure 1). The landslides are at localities 2, 3, and 5. All three slides are shallow-seated compared to the older slumps described in a preceding paragraph. The surface material at locality 3 is fill as much as eight feet thick. The original failure took place in lacustrine clay underlying the fill. The deposit formed by the slide consist of a jumbled mass of fill, clay, and trash originally buried in the fill. The landslides at localities 2 and 5 affected both bedrock and the overlying Saskatchewan Sands and Gravels. Because the displacement of the material by these slides is limited, the material is not as badly mixed as the deposit of the slide at locality 3. The nature and inferred origin of the slides are discussed in the section on engineering geology.

The bottom of the buried valley is sloping towards the northeast and is quite extensive in the area (Figure 1). It is partly filled by a potential aquifer, the Saskatchewan sands and gravels. The only likely recharge of any significant magnitude into the buried valley is groundwater from possible bedrock aquifers present in the southeast bank of the buried valley. The North Saskatchewan River has cut completely through the buried valley both in the north and southwest. Only small amounts of groundwater in the aquifer are expected from surface infiltration because of the impervious nature of the lake deposits and particularly the

As shown in Figure 1, three fresh landslides are present but all are small. Shallow-seated slides of this scale, however, will continue, and they will be especially prevalent at times of abnormally high precipitation. Rapid bank erosion will normally occur approximately at the same time, which may accelerate the growth of the slides. Features that are associated with these slides are trees inclined toward the river, tension cracks in the vicinity of the footpath just above the river, and ground water discharge from the bank. A description of the fresh landslides is given in the following paragraphs.
