# SAND AND GRAVEL RESOURCES OF THE FT. McMURRAY AREA

MAP SHEETS

Open File Report 1988-16
D.W. Scafe
W.A.D. Edwards
D.R. Boisvert
1988

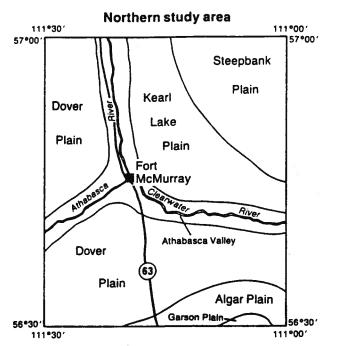
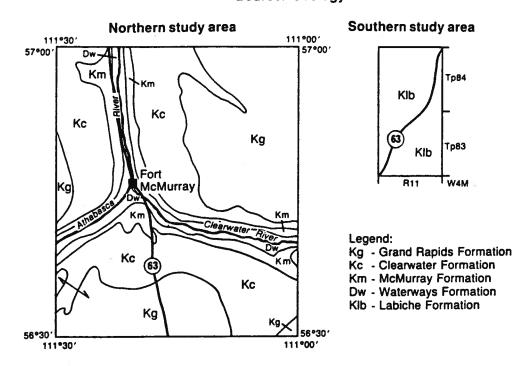
Figure 2. Physiography and Bedrock of the Study Area.

Bedrock (Figure 2) in the northern study area is mainly Early Cretaceous in age and is underlain by rock of Devonian Age. The Dover Plain District and the Kearl Lake Plain District are underlain by three formations of Lower Creatceous material. The McMurray Formation is a thick bedded, quartzose sandstone and siltstone, oil impregnated, marine deposit. The Clearwater Formation consists of dark gray, marine, fossiliferous, silty shale, laminated siltstone and fine grained cherty sandstone. The Grand Rapids Formation, consisting of fine grained quartzose and feldspathic sandstone, laminated siltstone and silty shale, is a shoreline complex deposit. The Steepbank Plain Section is underlain by the Grand Rapids Formation. The Waterways Formation of Devonian Age, underlying the Athabasca Valley District, is composed of marine, gray and geenish gray shale and argillaceous limestone interbedded with gray and greyish brown, fine grained to coarse clastic limestone.

Bedrock (Figure 2) in the southern study area is the La Biche Formation of Early to Late Creatceous Age. The formation consists of dark gray, marine shale and silty shale with ironstone partings and concretions and silty, fish scale bearing beds in the lower part.

Lowland Section covers parts of two townships and four ranges and reaches a maximum elevation of 490m. The Kearl Lake Plain, also in the McMurray Lowland Section, covers parts of three townships and three ranges and reaches a maximum elevation of 460m. The Athabasca Valley District in the Wabasca Lowland Section covers parts of four townships and four ranges and reaches a minumum elevation of 250m. The section in the Saskachewan Plains Region (Figure 2) is the Methy Portage Plains Section. Within this section, the Steepbank Plain District covers parts of three townships and two ranges and reaches a maximum elevation of 520m.

The southern study area plus the selected sites have physiographic features in one section from the Northern Alberta Lowlands Region and one section from the Northern Alberta Uplands Region. The section in the Northern Alberta Lowlands Region is the Wabasca Lowland Section which in turn is subdivided into two districts. The Wabasca Plain Districts covers parts of two townships and one range and reaches a minimum elevation of 550m. The Algar Plain District covers part of one township and one range and reaches a minimum elevation of 430m. The section in the Northern Alberta Uplands is the Stony Mountain Upland Section. Within this section is the Crow Lake Upland District which covers parts of two townships and one range, at a maximum elevation of 760m.

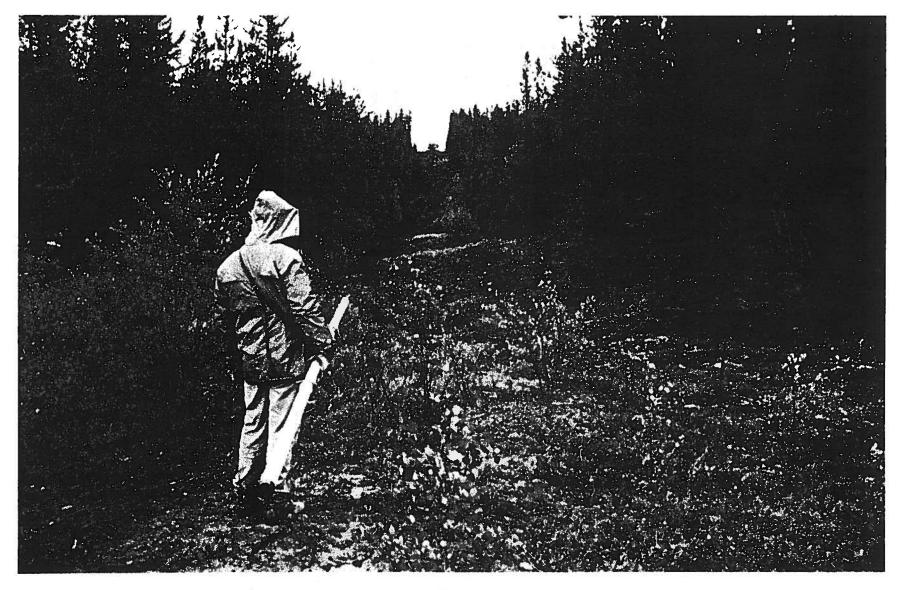
Plate 1. EM31 traverse across a large kame moraine deposit in LSD9 Sec7 Tp83 R11 W4M

All major gravel deposits in the northern and southern study areas have been located and exploited. There are small pockets of aggregate remaining as indicated in the site descriptions. However, our study indicates that no major deposits containing abundant clasts are present in the area. Any additional aggregate exploration in the region should focus on buried deposits which would show no surface expression and would not have been detected by this or previous research programs.

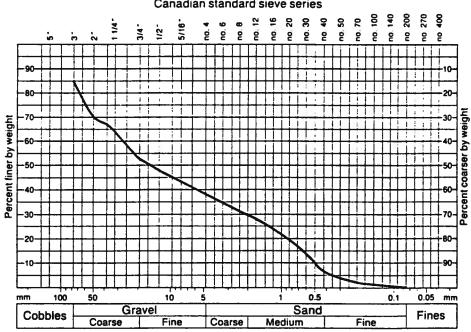
#### Gradation curve

Roadcut exposing 2m of clean, poorly graded gravelly sand overlying till and below 10cm of overburden. Maximum clast size is 75cm but most material is smaller than 4mm. Clasts are mostly subangular to subrounded igneous rocks from the Canadian Shield or quartzite. Ironstone clasts are abundant and commonly are broken. This is an isolated pocket of material with clasts as the material present in the surrounding area is sand.

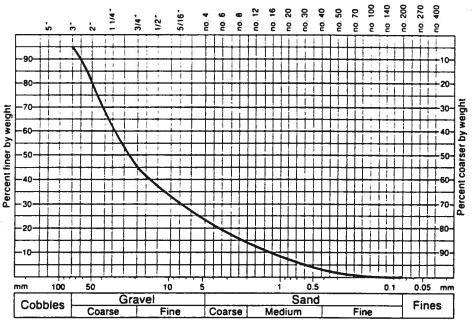
#### Gradation curve

Exposure of 5.75m of well graded, dirty gravel overlain by 10cm of overburden. Maximum clast size is 75cm - 1m. Clast are subangular to subrounded and sand grains are sharp. Igneous rocks from the Canadian Shield compose approximately 40% of the clasts with hard sandstone and quartzite each composing approximately 10%. Till clasts are common and are reported to be more common to the east. Horizontal bedding is poorly developed. A lens, 4m high and 10m long, of fine sand with minor pebbles is present below gravel at the east edge of the exposure. Iron stain blotches are present throughout.

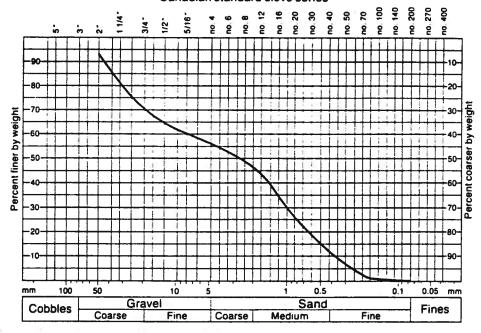
#### Gradation curve

Primarily fine sand with minor, local lenses of aggregate draped to the west over till. Sand is fine, clean and with iron stain common on bedding planes. Clay-rich silt or sand to 2m commonly is overburden. Maximum clast size is 1m but 85% of the material is finer than 4mm. Clasts are subangular to subrounded and consist primarily of igneous rocks from the Canadian Shield plus sandstone and quartzite. The sample was taken from a lens of aggregate.

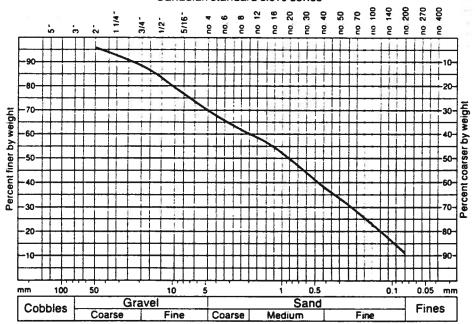
# Gradation curve

Test pit 1.75m deep in very dirty gravelly sand with abundant clay clasts overlying fine to medium grained, clean, iron stained, thin bedded sand. The clasts in the upper 1.25m are subangular to subrounded, compose 5% of the material and consist of igneous rocks from the Canadian Shield plus quartzite. A few oil sand clasts also are present. Results of a northward traverse with the EM31 indicate that the material probably is a continuation of very dirty gravelly sand.

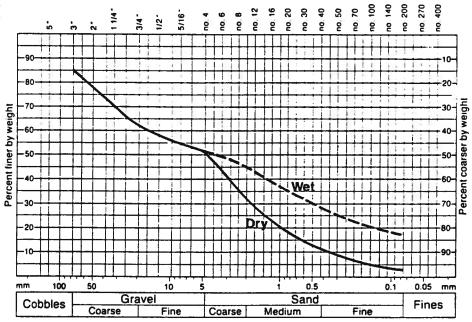
Gradation:	14.2% 48.8%	cobbles sand		gravel fines	dry	sieve
Sample 1						
	14.2%	cobbles	33.3%	gravel	wet	sieve
	34.9%	sand	17.5%	fines		
	2.7%	cobbles	40.4%	gravel	dry	sieve
	56.4%	sand	0.5%	fines		2012
Sample 2						Dec.
	2.7%	cobbles	40.4%	gravel	wet	sieve
	54.8%	sand	2.1%	fine

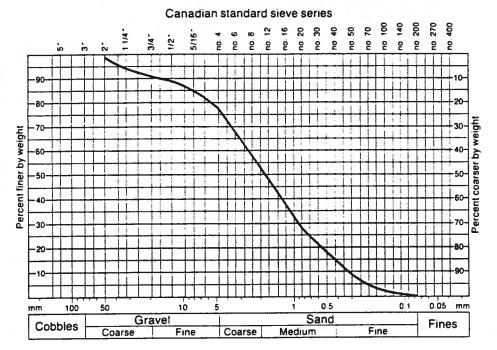
### Gradation curve

Gradation: 0% cobbles 22.9% gravel 76.3% sand 0.9% fines

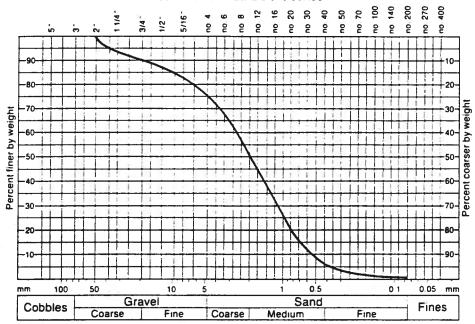
# Gradation curve

Gradation: 0% cobbles 24.8% gravel 74.4% sand 0.8% fines

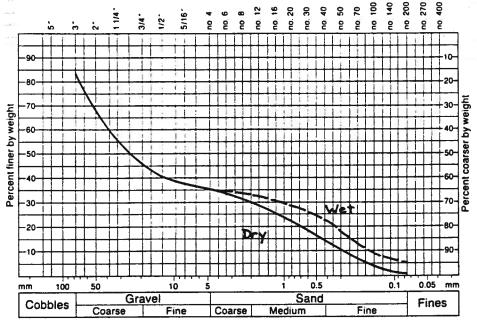
Gradation:	16.1%	cobbles	47.5%	gravel	wet	sieve
	29.7%	sand	6.6%	fines		
Sample 1						
·	16.1%	cobbles	47.5%	gravel	dry	sieve
	35.5%	sand	1.0%	fines		
	0%	cobbles	57.3%	gravel	wet	sieve
	36.3%	sand	6.4%	fines		
Sample 2						146
• • • • • • • • • • • • • • • • • • •	0%	cobbles	57.3%	gravel	dry	sieve
	41.1%	sand	1.6%	fines		645

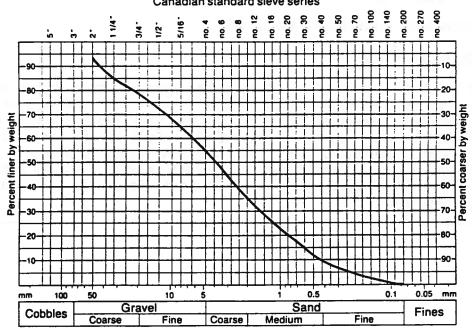
# Gradation curve

Gradation: 0% cobbles 44.0% gravel 55.0% sand 1.0% fines

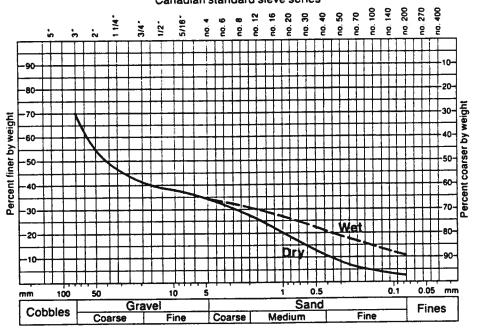
### Gradation curve

Gradation:	30.7% 30.9%	cobbles sand	gravel fines	dry	sieve
	30.7% 22.6%	cobbles sand	gravel fines	wet	sieve
	11.1% 53.7%	cobbles sand	gravel fines

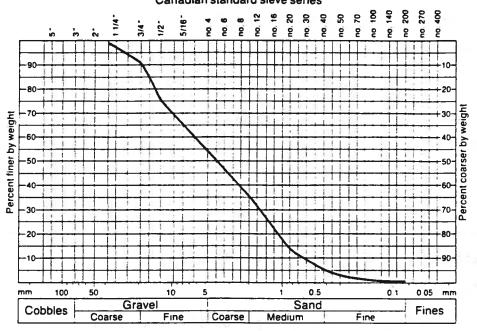
-63-Gradation curve Canadian standard sieve series

Gradation:	0% 53.8%	cobbles sand		gravel fines	
	0% 33.2%	cobbles sand		gravel fines	dry sieve
	0% 32.7%	cobbles sand	66.2% 1.4%	sand fines	wet sieve

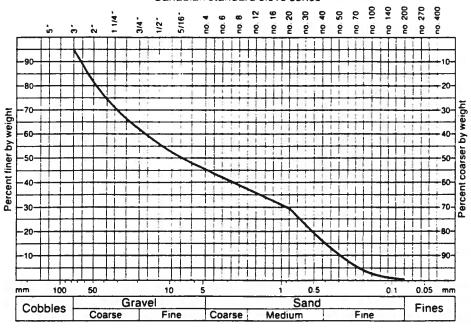
# Gradation curve

Exposure 9m high of indistinctly bedded sand and gravel. Upper 15-75cm is till with abundant sand and gravel. The material below is slightly dirty in some lenses but generally is clean. Some lenses are moderately iron stained. Maximum clast size is 40cm. Clasts compose 35% of the material and are primarily subangular to subrounded igneous rocks from the Canadian Shield with quartzite and hard sandstone. The presence of ironstone and abundant, crumbly schist clasts does not suggest this material is good for concrete production.
