Turtle Mountain Field Laboratory, Alberta (NTS 82G): 2013 Data and Activity Summary

AER/AGS Open File Report 2015-09

J.E. Warren, D.E. Wood, D.K. Chao and T.C. Shipman

February 2016

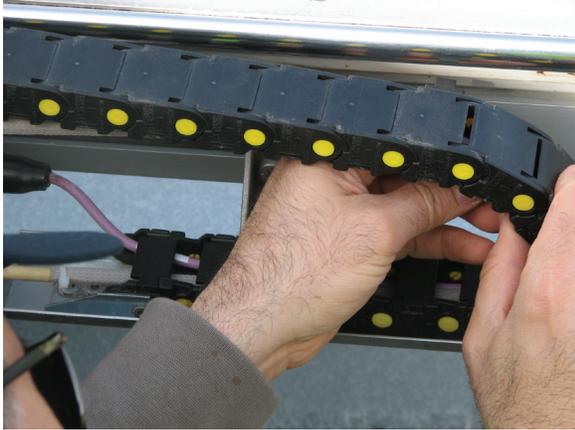
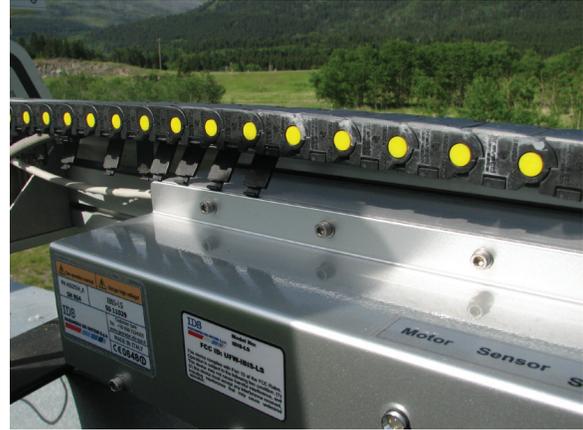
Figure 3. (a) IBIS GB-InSAR equipment rail track maintenance; (b) USB cable embedded in rail track; (c) IBIS GB-InSAR equipment rail, track, and radar head.

During installation a malfunction of the USB cable within the rail was noted. A system workaround was installed for the USB cable issue; however, the system continued to experience problems. These problems were shared with IDS and a June maintenance trip was scheduled.

IDS and AGS staff visited the pump house site in late June. During the visit the USB cable nested within the rail was replaced (Figure 3), the software was updated, and the frequency was changed back to the original AGS setting.

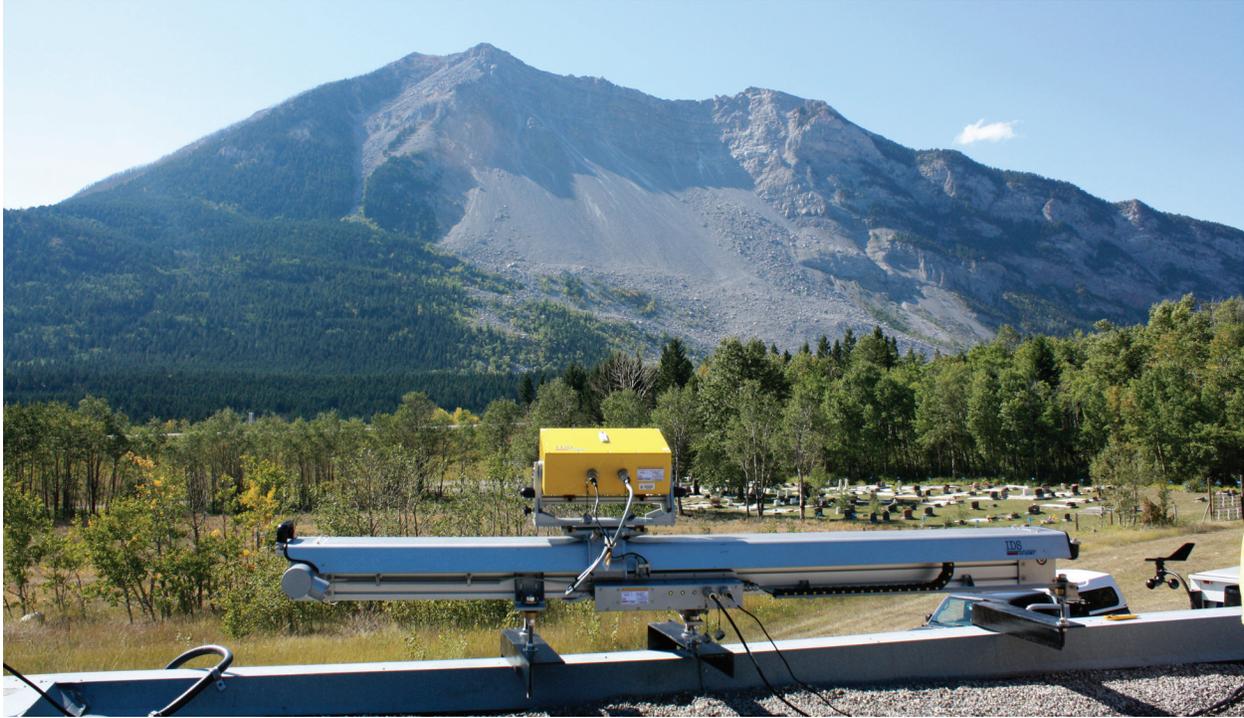
Beginning in April 2011, a ground-based radar device was installed for monitoring small displacements on the eastern face of the mountain. The IBIS GB-InSAR instrument uses the interferometric synthetic aperture radar technique to measure small displacements at each point on the surface of the mountain. The radar head moves back and forth along a 2-metre track approximately every 10 minutes, recording return phases of the radar signal (Figure 8).

The instrument was reinstalled in May 2013 after repairs were completed in the fall of 2012 due to calibration problems with the radar head. Shortly after installation, the AGS became aware of a change in the frequency setting for the radar head, which was reset to the Industry Canada standard. AGS holds

Figure 8. IBIS GB-InSAR equipment facing the eastern face of the mountain.

a licence for a frequency which provides a higher resolution. Because of this difference the manufacturer visited the site in June 2013 to change the frequency setting and to complete annual maintenance on the rail. A new USB cable was also installed within the radar head since the instrument had experienced communication problems between the instrument laptop and radar head. For the month of May and part of June, before the maintenance visit, the USB cable was bypassed. The IBIS system ran continuously after installation in May until June on the Industry Canada standard frequency and after the maintenance trip in June until early September. In September the instrument began to have communication problems again, which IDS has attributed either to USB communication problems or a glitch in the laptop programming. Newer software is available for the laptop and will need to be installed before next season.

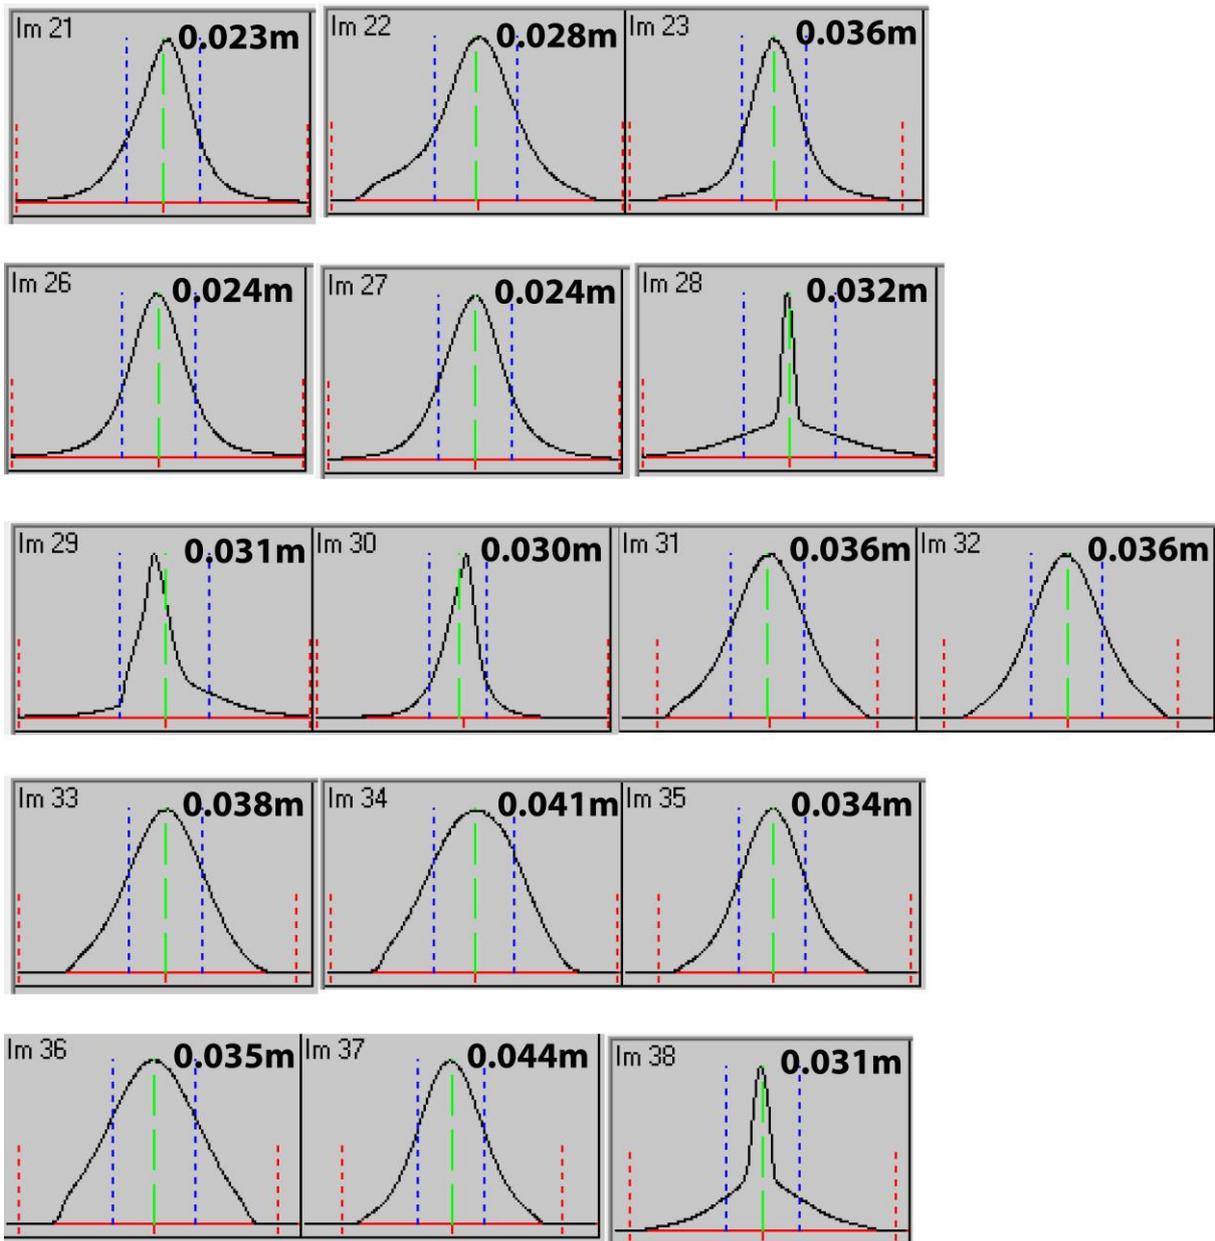
2013 – control scans piece-wise alignment on 2012 – reference point cloud: histograms and standard deviation.

Histograms of alignment (co-registration) of the different 2013 scans on 2012 – reference point cloud. The number of the different scans are reported in table 3 and the standard deviation of each alignment is shown.
