# **Turtle Mountain Decommission Project, Alberta (NTS 82G): Summary Report and Historical Signs**

**AER/AGS Open File Report 2018-02**

April 2018

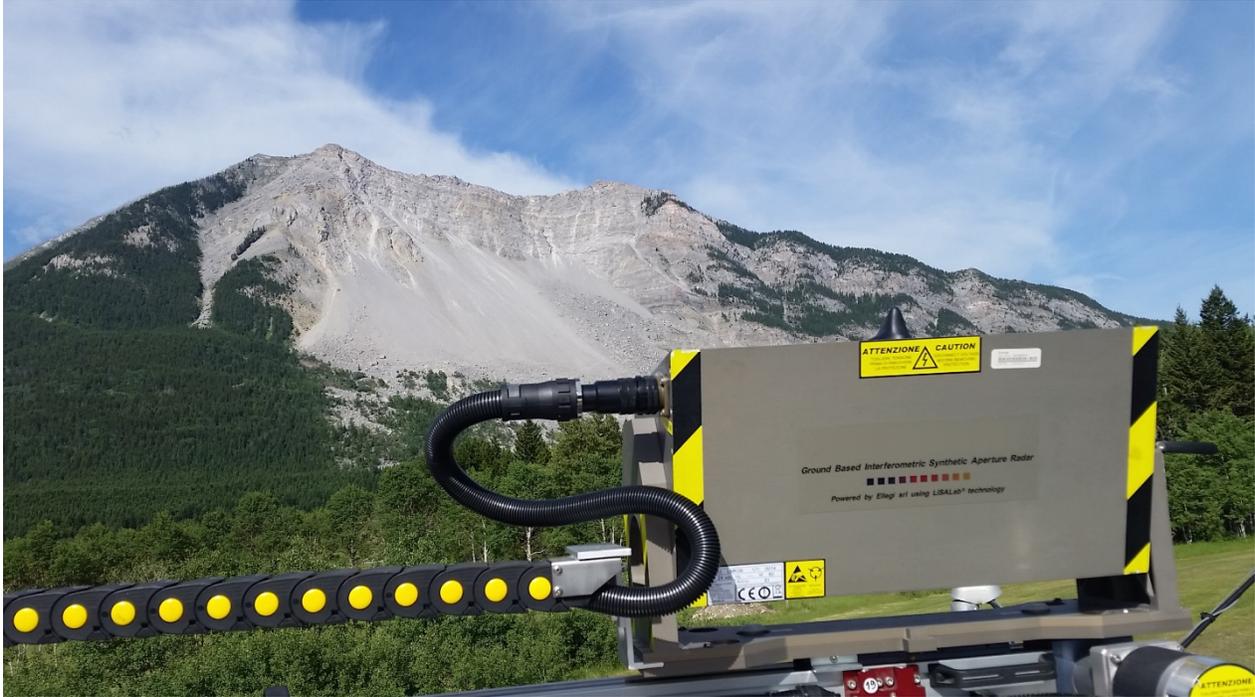
**Figure 1. LiSAmobile, overlooking South Peak of Turtle Mountain, Crowsnest Pass, Alberta.**

In June 2014, the AGS leased a GB-InSAR system known as LiSAMobile ([Figure 1](#)) for a one-year probationary period, giving us time to review the equipment and monitoring system. During this period, monthly data updates and monitoring reports were produced on a quarterly basis. This one-year pilot period allowed the AGS to verify that the services and equipment provided by Ellegi Srl. were optimal for monitoring surface displacements and had the ability to withstand weather extremes in the Crowsnest Pass (for detailed information on the operation and data collected, see Wood et al., 2016, 2017a). LiSAMobile continues to collect high-quality data with limited interruptions since installation. In 2016, the AGS transitioned to using the LiSAMobile system as the primary monitoring system for the TMMS, with secondary monitoring campaigns selected by the AGS on an annual basis (Wood et al., 2017b). The AGS will continue to evaluate LiSAMobile and investigate newer forms of monitoring systems for the Turtle Mountain Field Laboratory (TMFL).

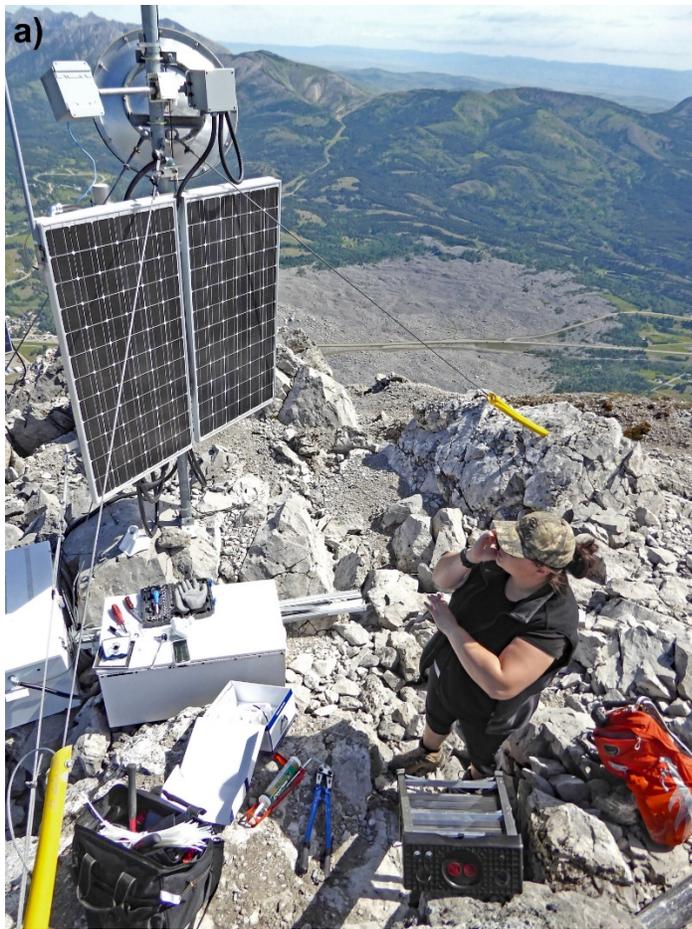
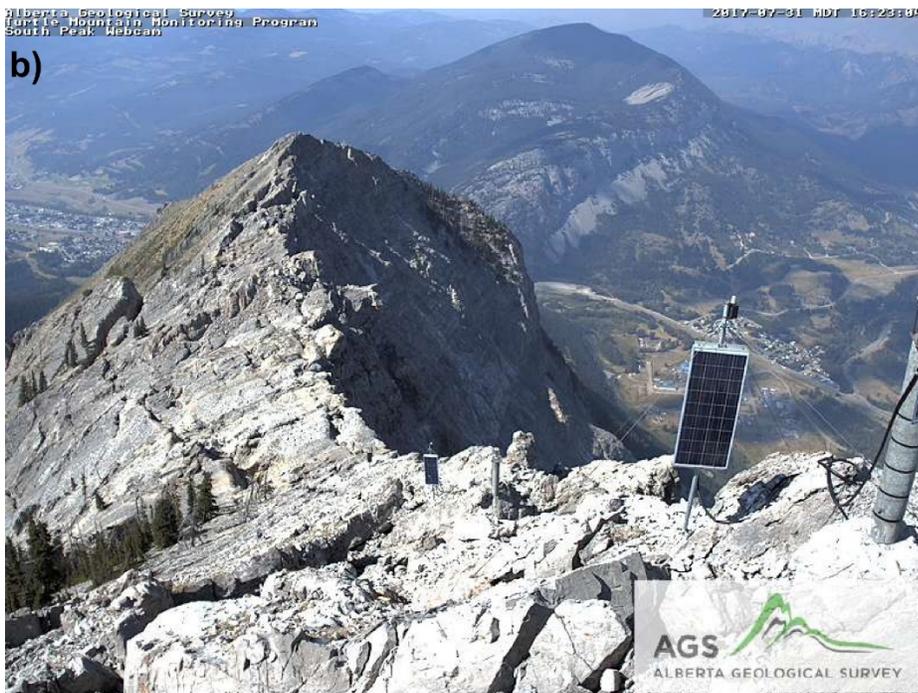
One group of two AGS employees was tasked with the replacement of the web camera located at South Peak ([Figure 2a](#)). The previous Mobotix M22 camera was replaced with a newer M25 model. The decision to replace the web camera was based on several reoccurring issues with the older M22 model, including:

- poor image quality as a result of low megapixels and outdated technology,
- constant unexplained reboots of the camera, and
- inadequate communication transmissions to the AER network.

Figure 2. a) Replacement of the South Peak web camera. b) Image from the new South Peak web camera.

Replacement of the web camera installation was straightforward, with the new camera solving the above problems and producing a higher quality video stream ([Figure 2b](#)).

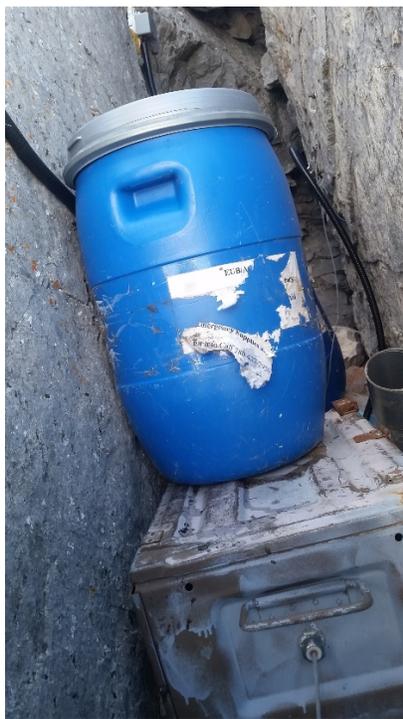
If hikers or visitors become stranded on top of Turtle Mountain as a result of injury, fatigue, or change in weather conditions, they can access a survival kit housed in two blue waterproof plastic safety barrels near the weather station, one of which is shown in [Figure 4](#). The kit includes items such as a utility knife, utensils, broadcast radio, flashlight, batteries, blankets, sleeping bags, waterproof matches, water and purification tablets, wick candles, camp stove with fuel, heat packs, and basic first-aid kit.

**Figure 4. One of the two safety survival barrels located in the cracks near the weather station.**

These survival barrels also contain an approximately 48-hour supply of high-energy food rations for two people (or four people for 24 hours), including instant coffee and soup packages, hot chocolate, mixed nuts, sugar, and granola bars. All consumables are vacuumed sealed, and most of them will not expire until 2020. All expired rations, such as granola bars and mixed nuts, were removed and replaced with a fresh stock. An inventory of the emergency barrels was conducted and the internal inventory was updated to reflect these changes in the *Turtle Mountain Field Laboratory Safety Manual* (Alberta Geological Survey, 2016) in 2017.

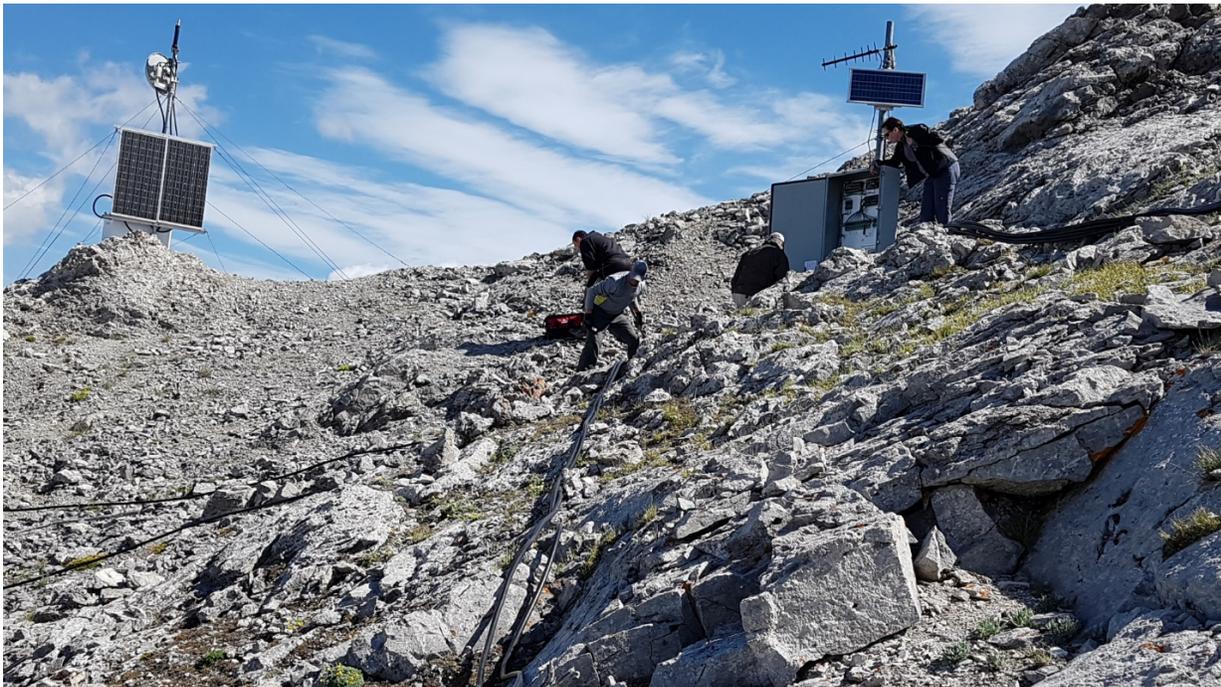
The third group focused on dismantling the borehole, located approximately 10 m below the South Peak monitoring station. As seen in [Figure 5](#), the borehole station consisted of a solar panel, battery boxes, dataloggers, multiplexors, and a wireless router, which served as the data collection and transmission site for the monitoring sensors: crackmeters, extensometers, and tiltmeters.

**Figure 5. AGS field crew dismantling the borehole hub and conduit lines leading to multiple monitoring equipment locations.**

To decommission the station, the battery and solar panel were disconnected, followed by all sensor connections. The dataloggers, multiplexors, and the router were left in the enclosure for ease of transport. The conduit housing the wires to each of the external sensors was then disconnected from the metal enclosure. Once all connections were severed, the guy-wires were loosened and the main mast was disconnected. When the mast was free, the enclosure and solar panel were separated from the mast to prepare them for slinging.

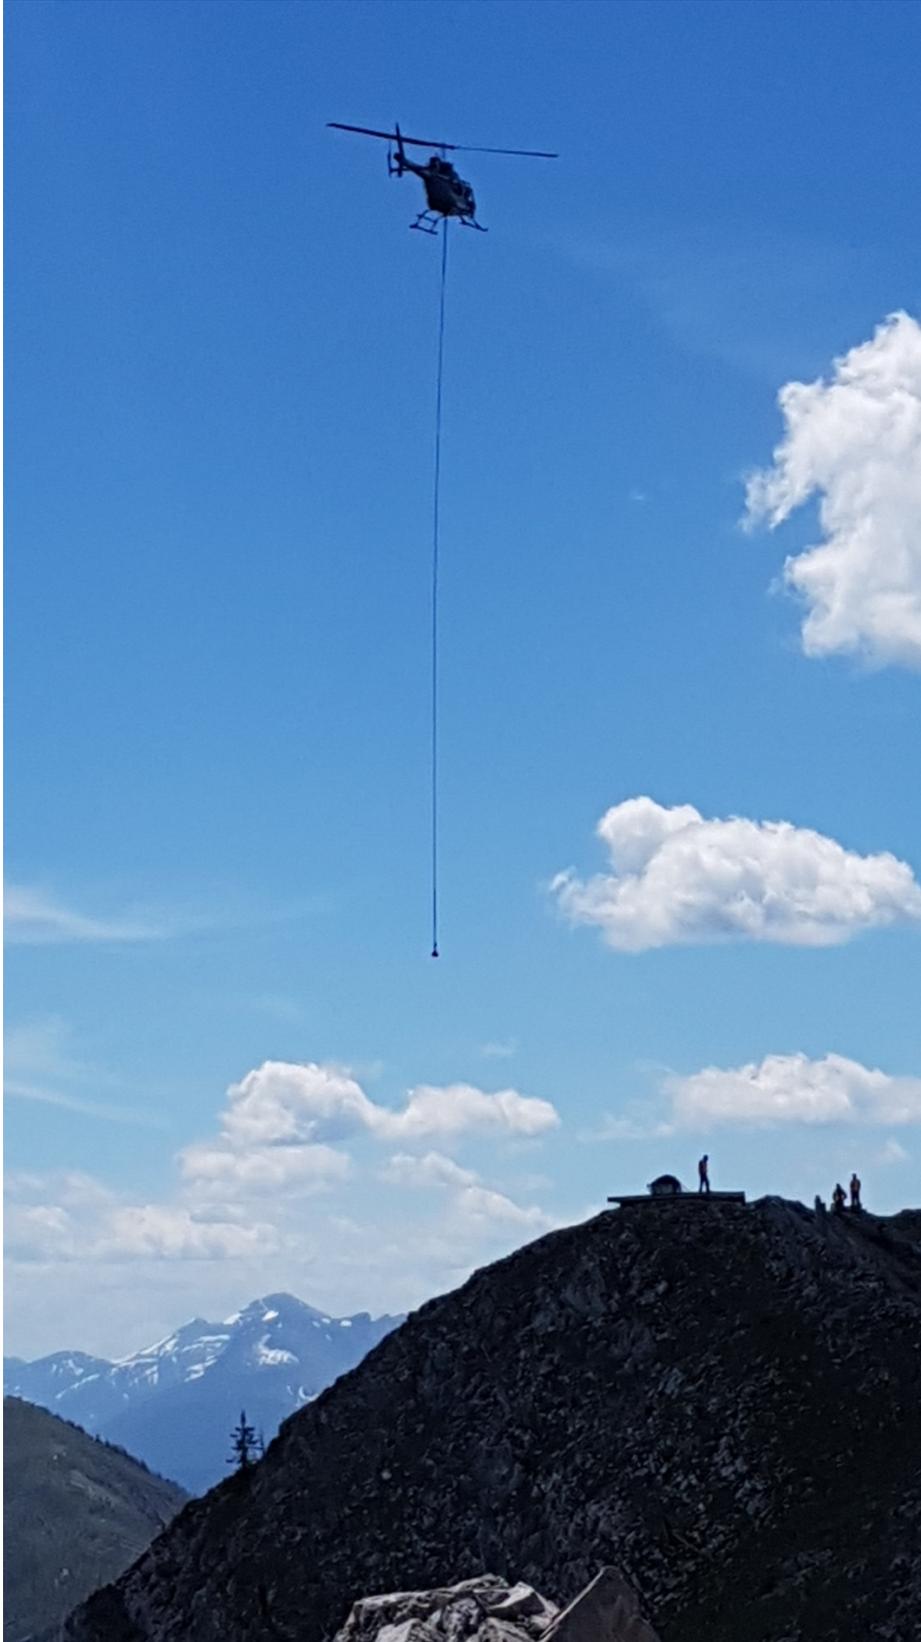
One of the critical components of the decommission project was the clean-up and transportation of the equipment from the mountaintop to the valley below. Several locations on the mountain were selected as slinging and staging areas. They were chosen according to their relative flatness, ease of access for the helicopter, lack of trees, and general visibility from the surroundings ([Figure 8](#)).

**Figure 8. Equipment removal from South Peak by helicopter.**

Due to the potential risks of the operation, constant communication between the helicopter pilot and the field leaders was mandatory. To further increase everyone's safety, a limited number of employees were allowed to be near the slinging area and responsible for equipment loading. All employees were required to wear safety vests for maximum visibility from the helicopter.

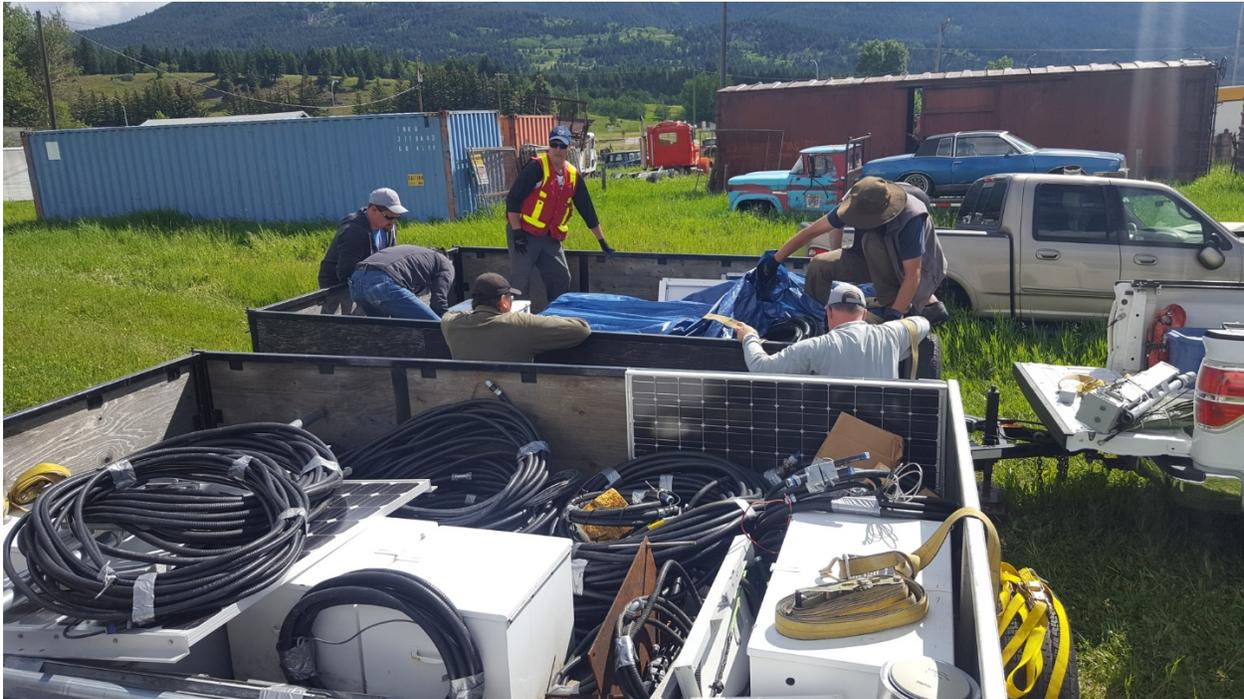
A group of three field-crew members was located at the base of the mountain and responsible for unloading the cargo nets, organizing materials, and packing the trailers according to the *Turtle Mountain Field Laboratory Safety Manual* (Alberta Geological Survey, 2016). Final packing of the trailers is shown in [Figure 9](#).

Figure 9. Equipment loaded onto trailers for transportation back to Edmonton.

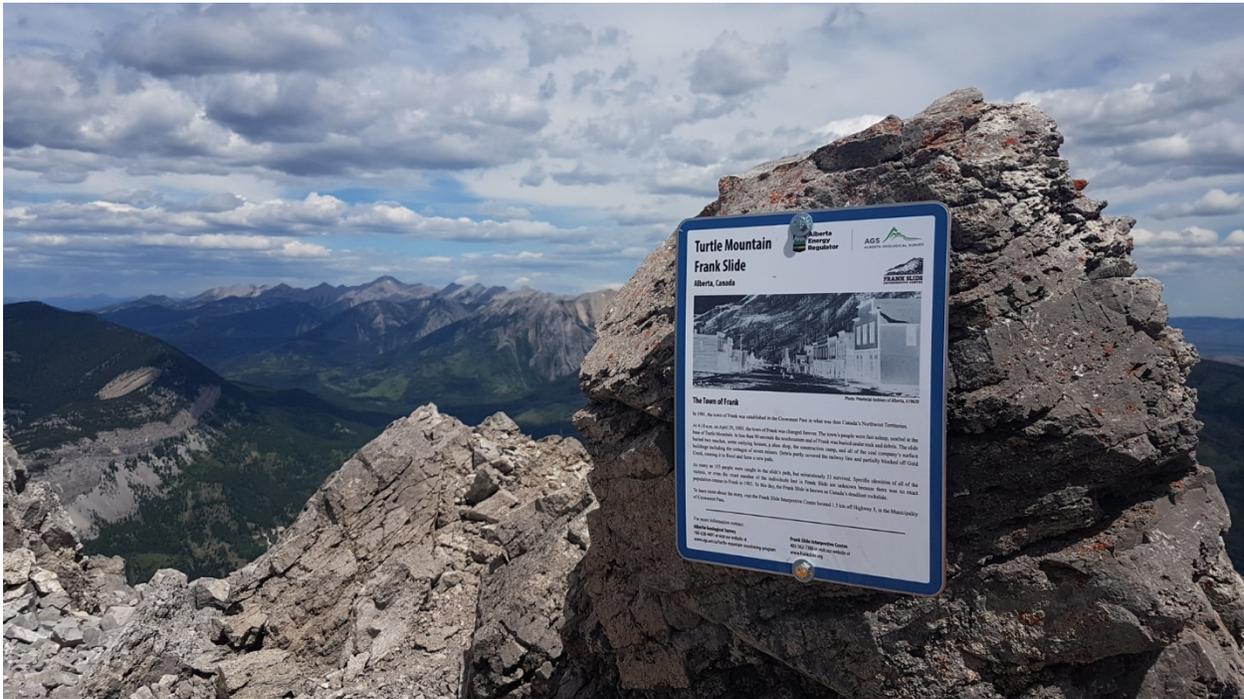
Six historical signs were created in collaboration with the Frank Slide Interpretive Centre (FSIC) that provide information and education to hikers on the historical monitoring equipment that remains in place. The signs were printed on aluminum, weather-resistant material and attached to rocks on South Peak ([Figure 10](#)) with weather-resistant bolts. Sign locations were chosen with the FSIC for ease of access to hikers.

Figure 10. Sign installed on South Peak commemorating the Town of Frank, devastated by the Frank Slide of 1903.
