**Turtle Mountain Field
Laboratory, Alberta (NTS 82G):
2018 Data and Activity
Summary**

AER/AGS Open File Report 2019-07

D.E. Wood and D.K. Chao

Alberta Energy Regulator
Alberta Geological Survey

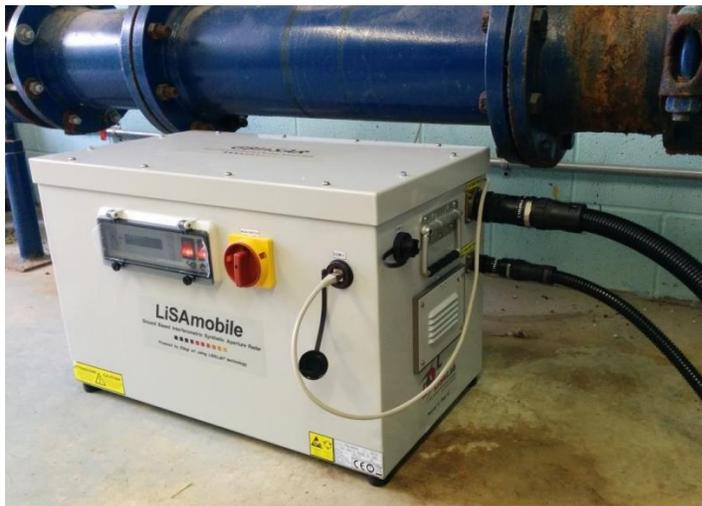
Figure 3. Upgraded internal computer unit installed during LiSAmobile annual maintenance.

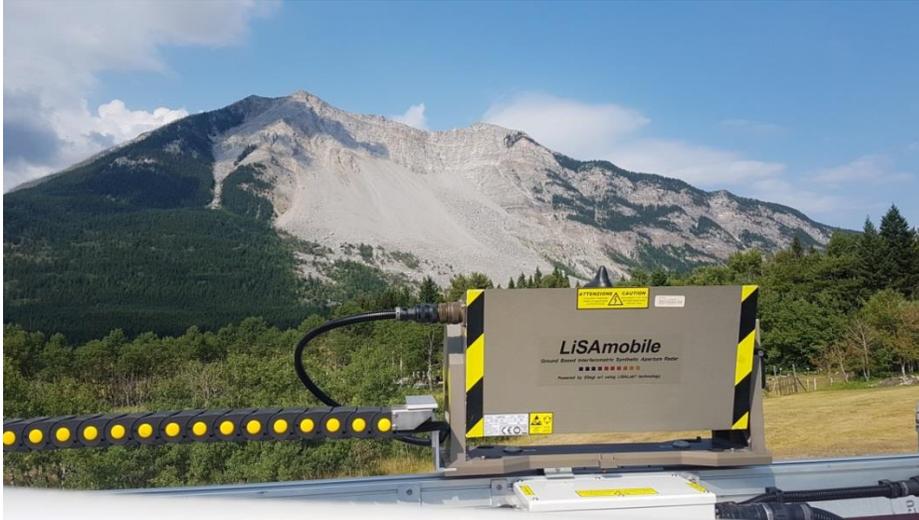
Figure 5. LiSAmobile system without radome.

LiSAMobile was installed at the Bellevue pump house in June 2014 to monitor small displacements on the eastern face of Turtle Mountain. The LiSAMobile GB-InSAR (Figure 5) uses the interferometric synthetic aperture radar technique to measure small displacements at each point on the surface of the mountain. For additional information, the reader may refer to Wood et al. (2018).
