Turtle Mountain Field Laboratory, Alberta (NTS 82G): 2019 Data and Activity Summary

AER/AGS Open File Report 2020-07

D.E. Wood and D.K. Chao

Alberta Energy Regulator
Alberta Geological Survey

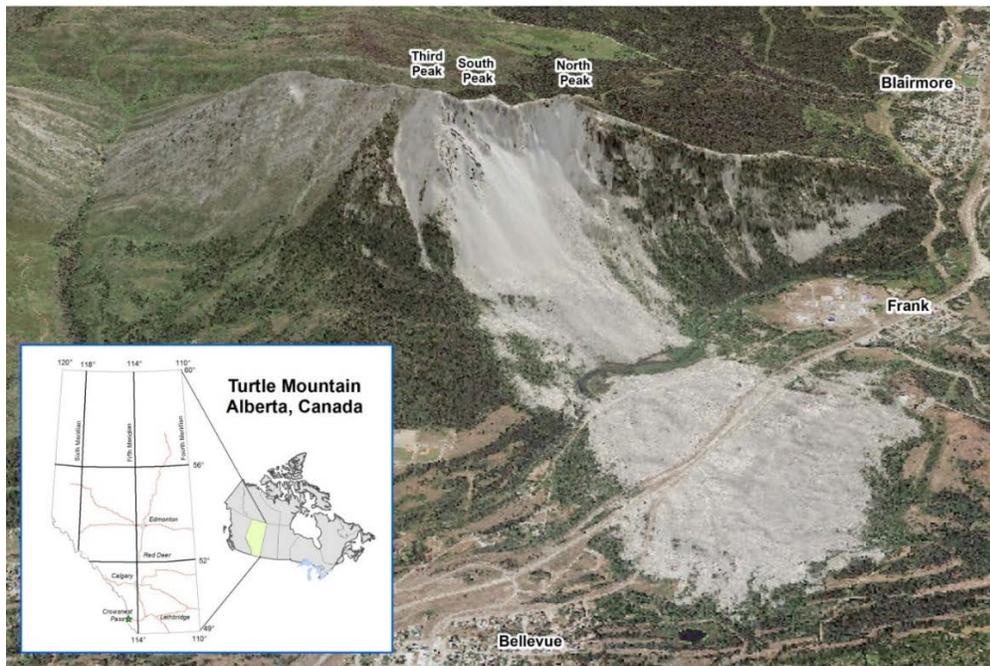
Figure 1. Location of Turtle Mountain in southwestern Alberta and full-extent aerial view of the Frank Slide.

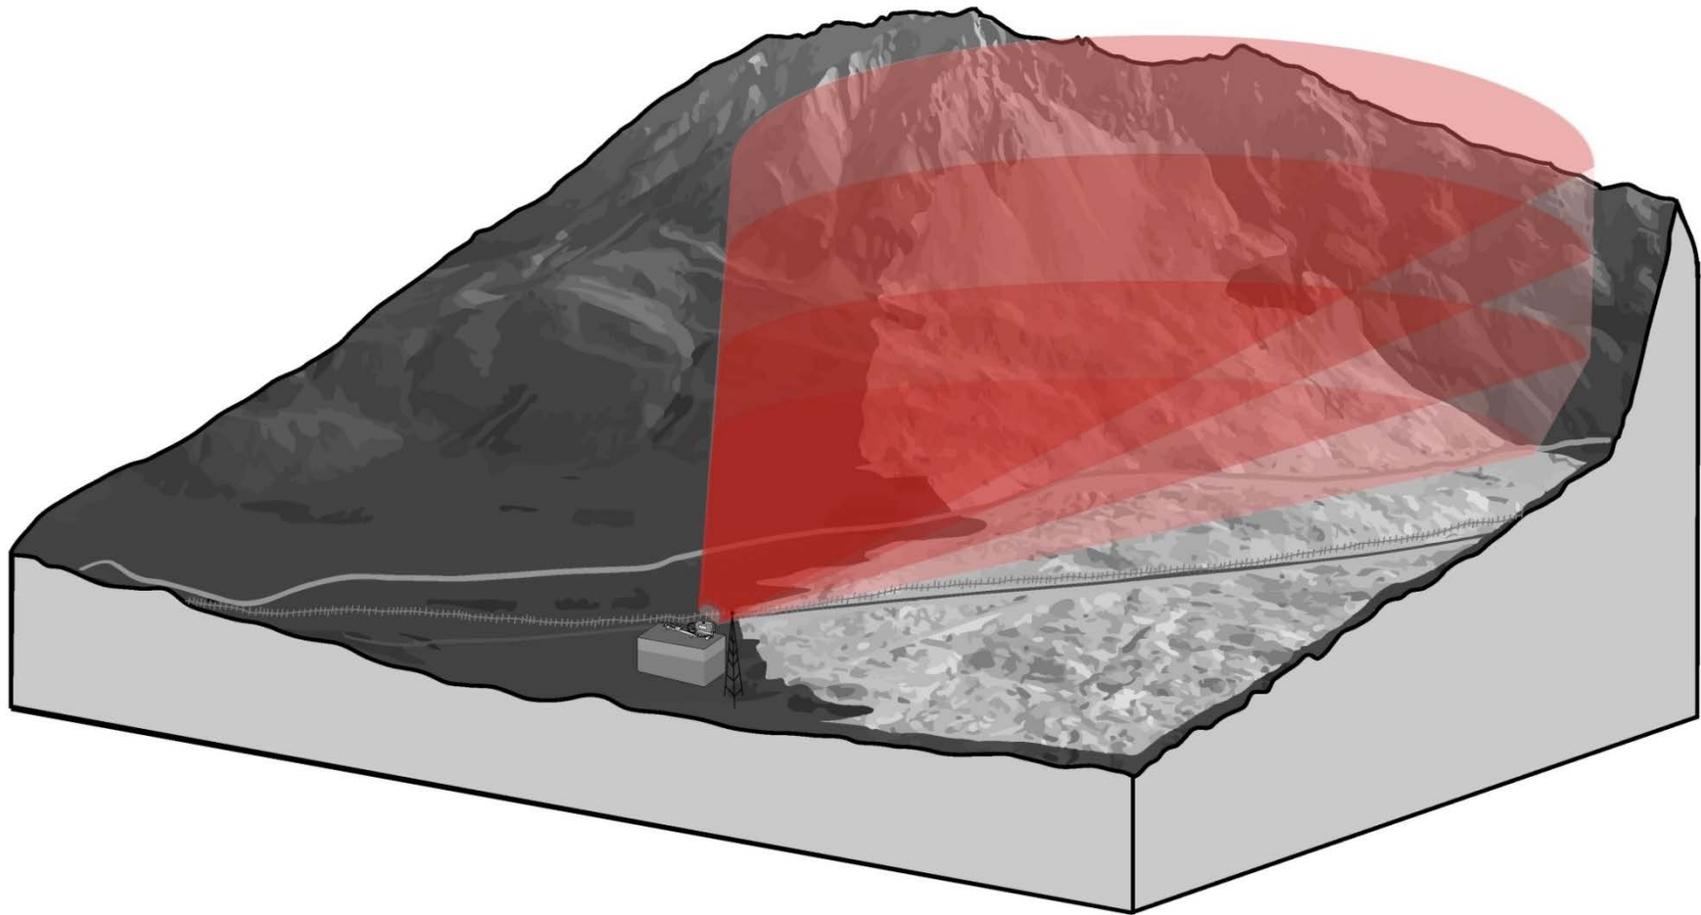
Figure 2. Overview, as of December 2019, of the primary monitoring equipment. The drawing marks the location of the LiSAMobile system, and the red beam depicts the scanning of the mountain. The light grey area represents the extent of the original 1903 slide. The image is not drawn to scale, and its purpose is to highlight the area LiSAMobile scans.

In 2016, LiSAMobile was transitioned from being the secondary monitoring system to the primary monitoring system ([Figure 2](#)). In addition, AGS also uses secondary monitoring campaigns. These secondary monitoring campaigns, such as aerial light detection and ranging (LiDAR) scanning, photogrammetry, terrestrial laser scanning (TLS), etc. are selected by the AGS based on monitoring frequency. In 2019, no secondary monitoring campaign was selected for supporting studies and research ([Section 4](#)).

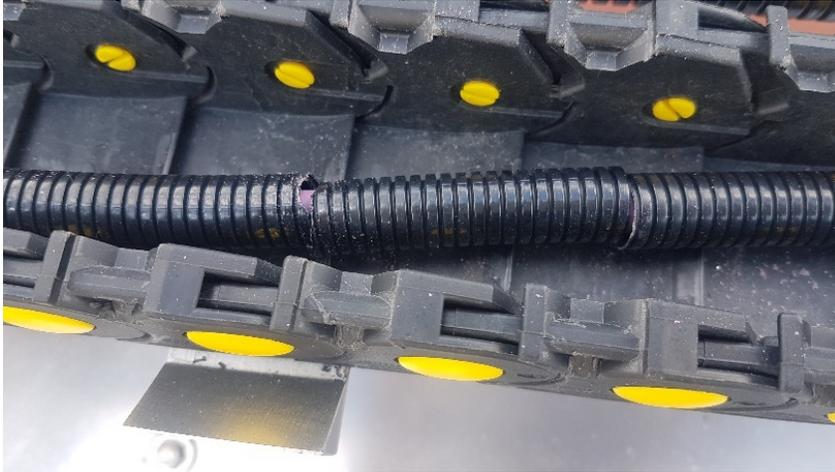
One week before site maintenance, LiSAMobile had stopped transmitting data to Milan, Italy. Upon inspection during the maintenance, it was determined that the chain cable, a flexible plastic conduit for the data cable connected to the radar, was damaged due to continuous motion ([Figure 3](#)). The conduit had cut into the data cable and prevented data from communicating with the internal computer. The entire

Figure 3. Damaged chain cable had cut into the data cable causing it to fail.

damaged cable was replaced, and new stepper motor controller and serial-to-lan converter were installed. In addition, a system upgrade was performed to improve the 'stop&go' with 'continuous' images acquisition mode. The new acquisition mode will enhance data capturing capability and improve overall measurement accuracy.

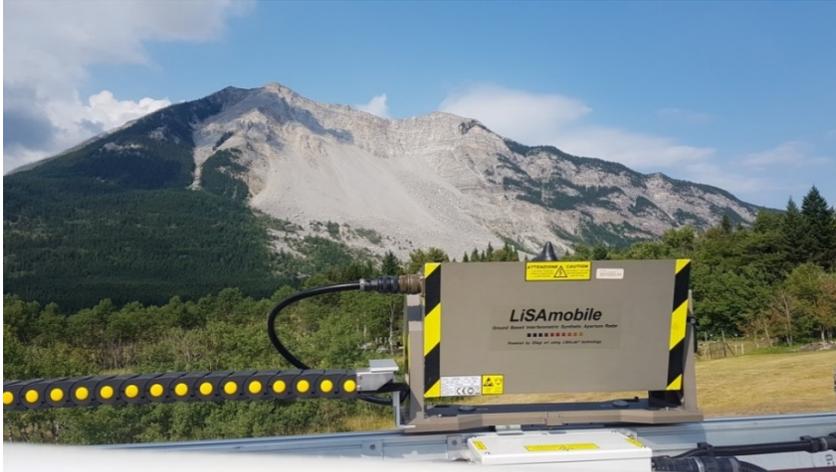
LiSAMobile was installed at the Bellevue pump house in June 2014 to monitor small displacements on the eastern face of Turtle Mountain. The LiSAMobile GB-InSAR ([Figure 4](#)) uses the interferometric synthetic aperture radar technique to measure small displacements at each point on the surface of the mountain. For additional information, the reader may refer to Wood et al. (2016).

Figure 4. LiSAmobile system without radome.

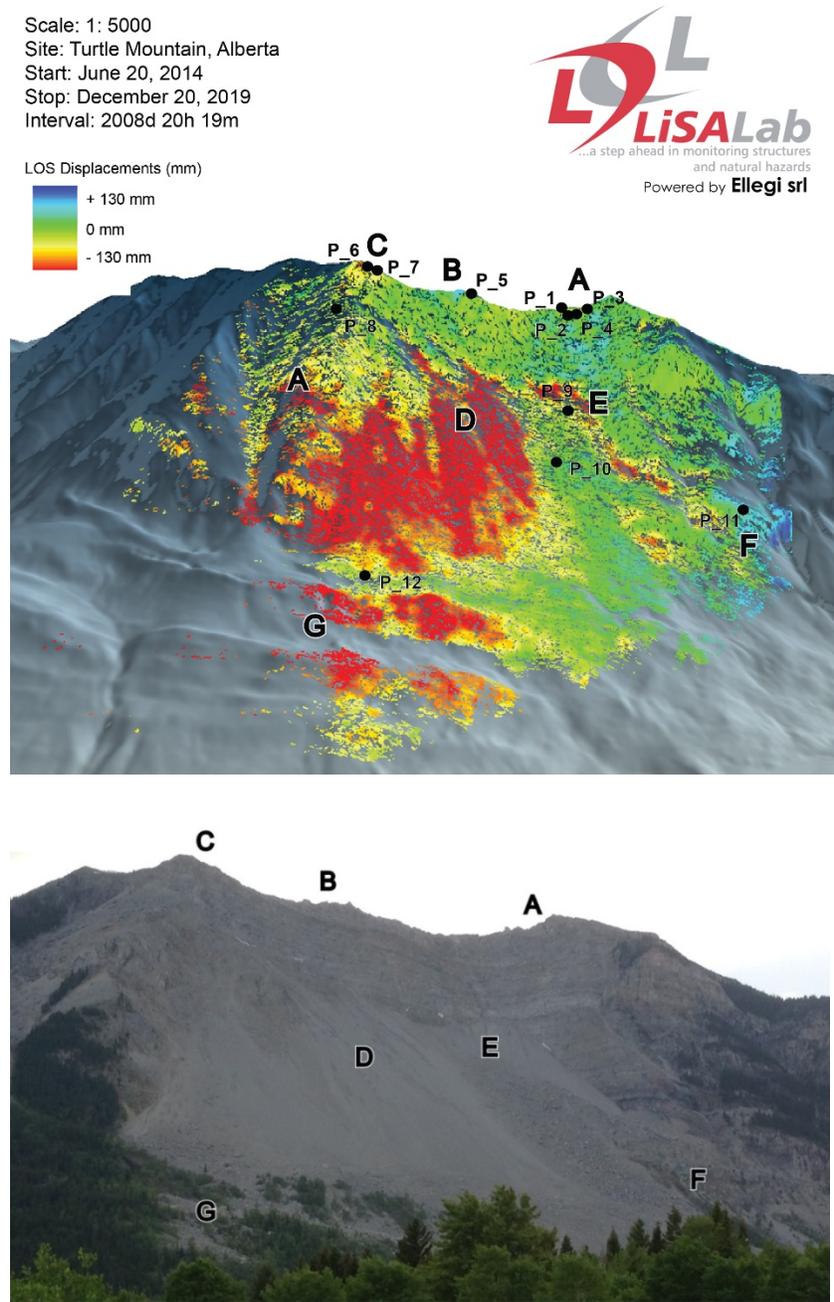
The displacement map displayed in Figure 5 depicts how the slopes on the east face of the mountain are affected by slow and small movements, measured in the millimetre range. Displacement maps are created through a collection of data from the LiSAmobile system over a 91-day period (per quarter), with approximately 15-day increments. The displacement maps were produced from data collected from the start of LiSAmobile operation in June 2014 to the end of December 2019 and are provided by Ellegi to the AGS in quarterly reports (Q19 to Q22 for 2019). Each report contains the cumulative data starting from June 20, 2014, to the end of the respective quarterly reporting period.

The data are divided into seven regions (A–G, Figure 5), which are further subdivided into twelve points of interest (POIs; labelled P_1 through P_12 in Figure 5). Additional documentation of the LiSAmobile parameters can be found in Wood et al. (2016).

The high displacement rates detected in the vegetation zone (region F, Figure 5) are considered to be measurement errors introduced by atmospheric moisture within the line of sight.

Figure 5. Three-dimensional (3D) displacement map (top) measured from June 20, 2014, to December 20, 2019, and view of the eastern face of Turtle Mountain (bottom). Letters A to G denotes the location of regions described in [Tables 1 to 8](#). Abbreviations: d, day; h, hour; LOS, line of sight; m, minute.

On the displacement maps (Figures 5 and 7) both positive and negative displacement values are depicted using colours. Blue colours indicate displacement away from a sensor (positive value), for example, rocks calving off and exposing new rock surfaces from behind. Red colours indicate displacement towards the sensor (negative value), such as rocks falling and accumulating in the debris zones (regions D, E, and G). Green colours depict a neutral range of displacement with minimal movements towards or away from the sensor.

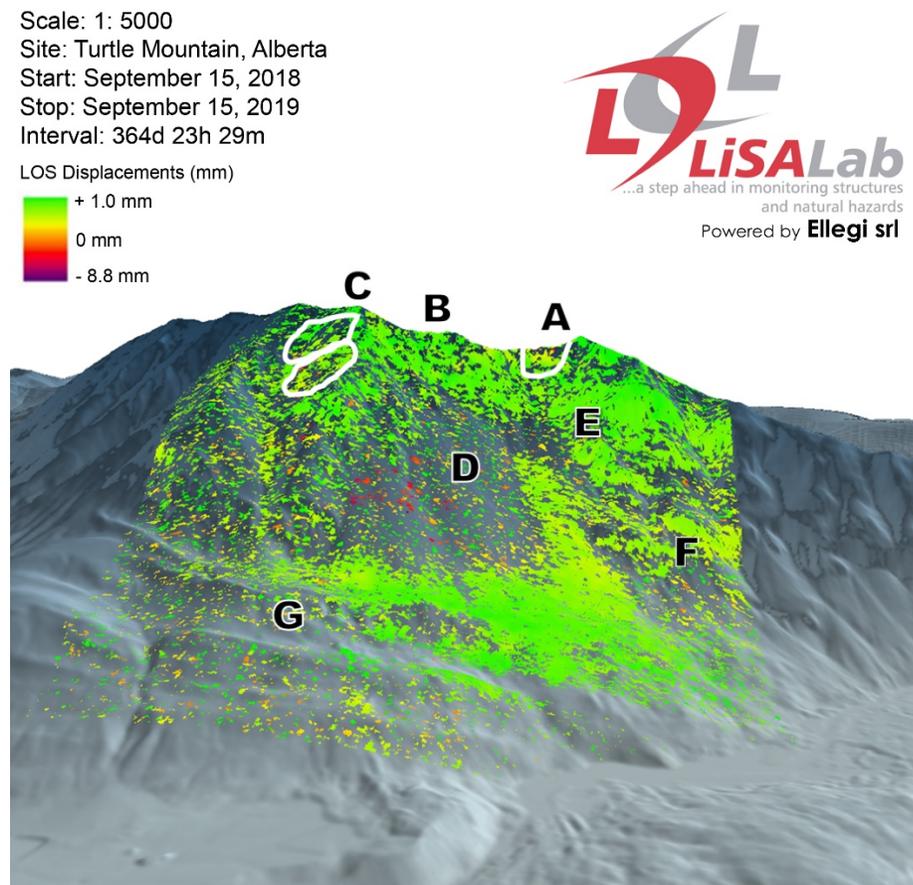
In 2019, the same study was completed between September 15, 2018, and September 15, 2019. This analysis determined the upper block near region C (Figure 6) displayed movements of about 1.4 mm on average, with some peaks displaying a maximum displacement of more than 4.0 mm. The lower block, near region C (Figure 6) moved similarly and displayed movement of about 1.5 mm on average, with some peaks displaying a maximum displacement of more than 8.0 mm.

In addition, Ellegi also identified a third area with a very slow rate of displacement over a larger area near region A, close to North Peak. Over the one year, an area of about 5500 m² displayed movements of about 2.7 mm on average in the larger block, with some peaks displaying maximum displacement of more than 8.5 mm (Figure 6). The annual analyses on this block displays the rate of displacement measured in this area is lower than the rate measured from September 2017 to 2018.

Figure 6. Annual analysis of large block movements near regions A and C, from September 15, 2018, to September 15, 2019 (364 days, 23 hours, 29 minutes). Abbreviation: LOS, line of sight.

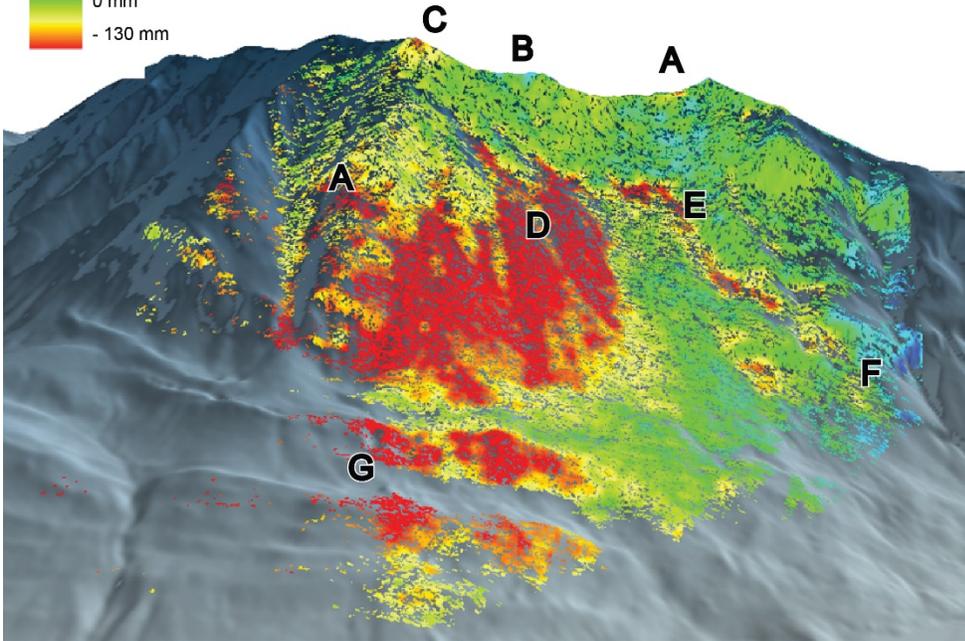
Scale: 1: 5000
Site: Turtle Mountain, Alberta
Start: June 20, 2014
Stop: December 20, 2019
Interval: 2008d 20h 19m

Figure 7. The line-of-sight three-dimensional (3D) displacement map of Turtle Mountain measured from June 20, 2014, through December 20, 2019 (2008 days, 20 hours, 19 minutes). Abbreviation: LOS, line of sight.
