RESEARCH COUNCIL OF ALBERTA

REPORT 72-5

TRAIL CONDITIONS ALONG A PORTION OF
THE GREAT DIVIDE TRAIL ROUTE,
ALBERTA AND BRITISH COLUMBIA ROCKY MOUNTAINS

J.D. Root and L.J. Knapik

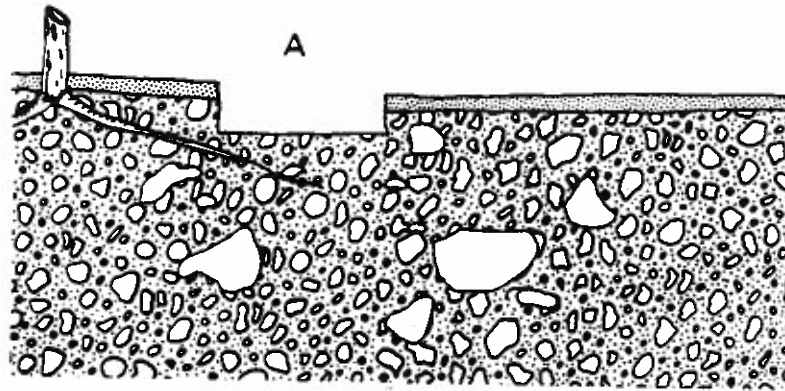
Several stages of trail erosion by running water are shown schematically in figures 3 to 8, where the trail is situated on unconsolidated glacial or alluvial sediments overlain by a thin turf layer. This type of trail erosion leads to expensive maintenance, reconstruction or rerouting of trail, and to unpleasant hiking and riding.

Figure 3. Original condition. Trail (A) is constructed by removing turf overlying till.

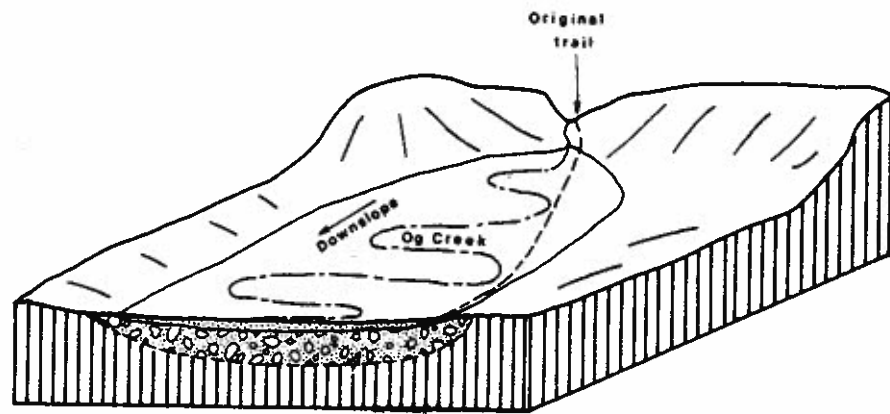
The plain immediately south of Og Lake (Plate 7) provides a good example of the potential hazards to be found in such areas. The original trail was built straight across the plain, i.e., parallel to the regional slope, being located close to one of the meanders of Og Creek (Fig. 12). With time, horse and foot traffic compacted the soil until a rut was worn. At the same time, Og Creek gradually eroded the outside meander bank and cut into the trail rut, which provided a more direct route down-slope, and streamwater flowed down the trail (Fig. 13). Subsequent annual erosion has removed so much material from the original rut that the trail is now the major channel of Og Creek (Plate 8). The new trail, built immediately to the west of and parallel to the original trail, soon will be incorporated as Og Creek erodes laterally (Fig. 13).

Figure 12. Location of original trail through alluvial plain just south of Og Lake.

This type of trail damage has occurred to a lesser degree in each of the alluvial plains between Og Lake and Wonder Pass. In each case, placing of the trail on the side slopes above the plain would avoid such damage (Fig. 14 and Plate 9).

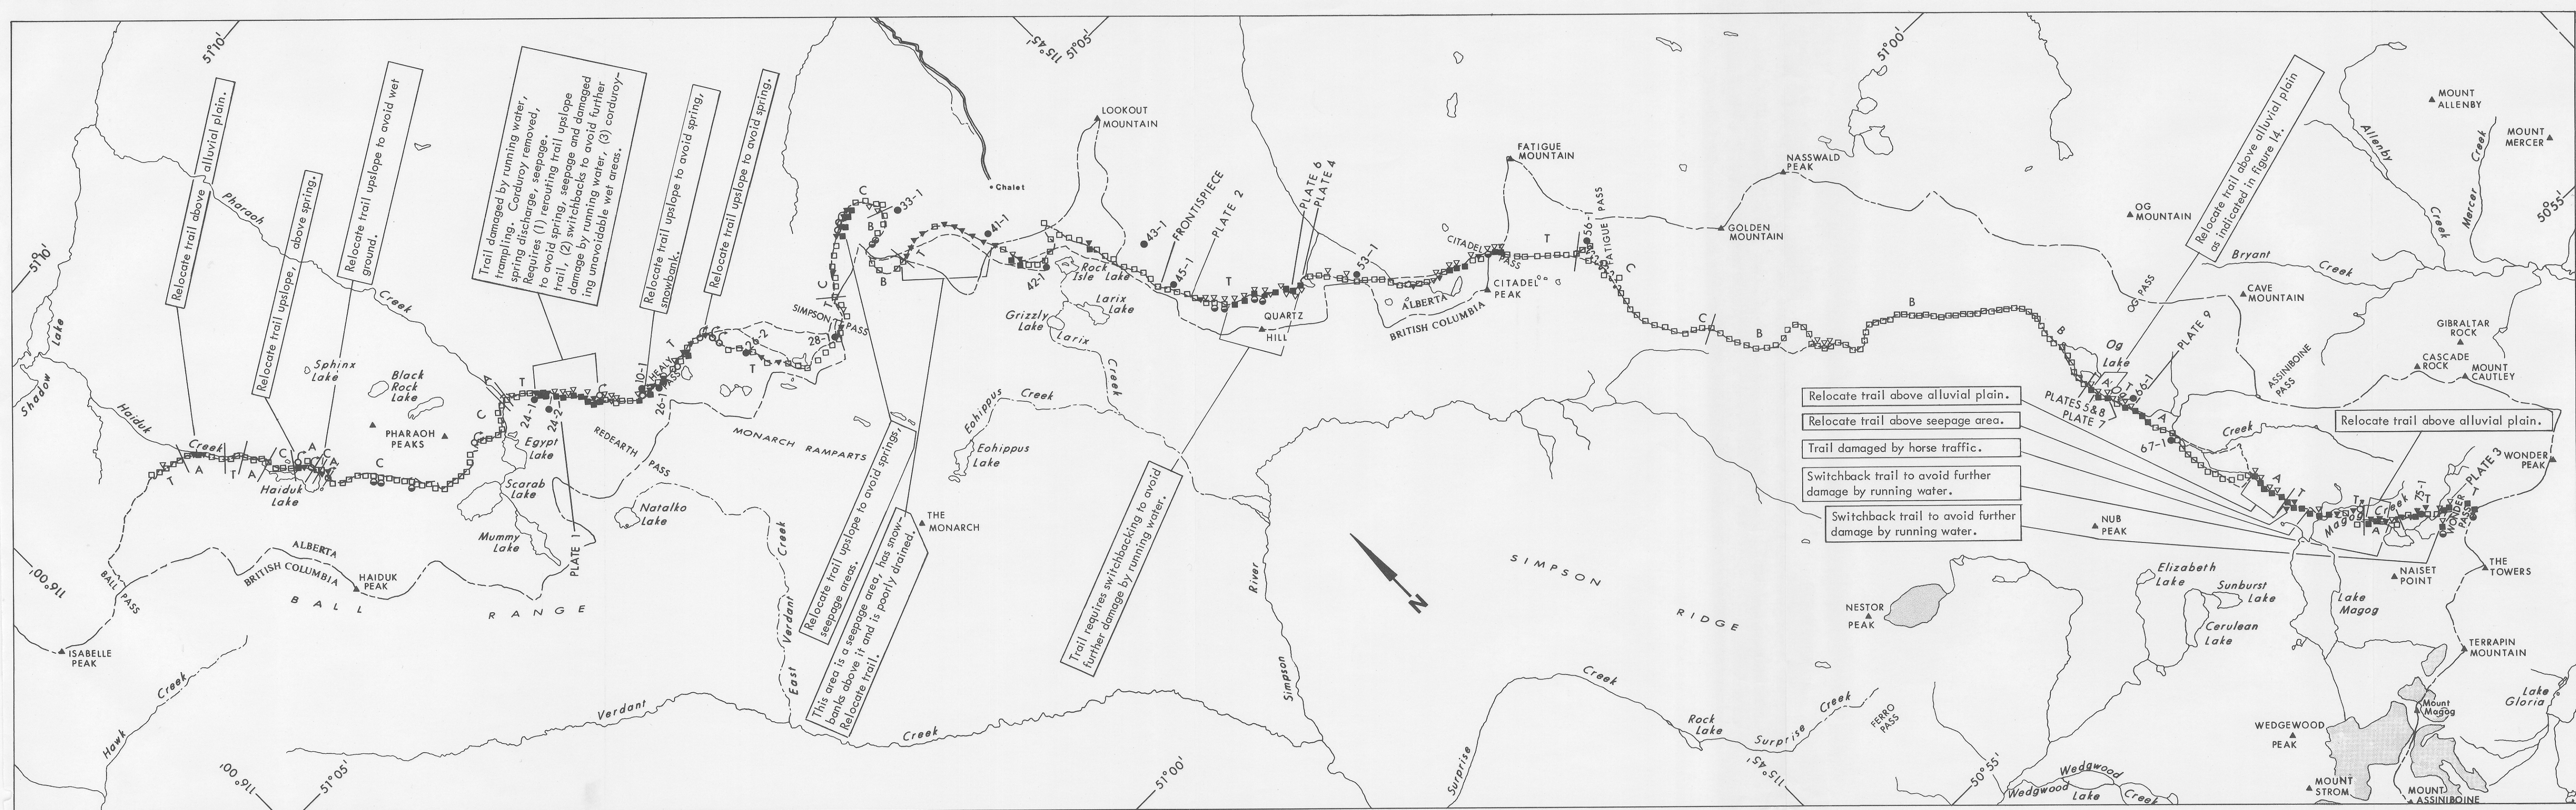
Approximately 20 per cent of existing trail along the route between Haiduk Lake and Wonder Pass was classed as damaged during the 1971 survey. Trail was considered damaged if it was deeply rutted or markedly V-shaped; if it contained loose boulders,
